Metallurgical Examination of a Failed  
Blade Lag Shock Absorber  
(Part No. 114H6802) From a CH-47D  
Chinook Cargo Helicopter

ARL-TR-2191

March 2000

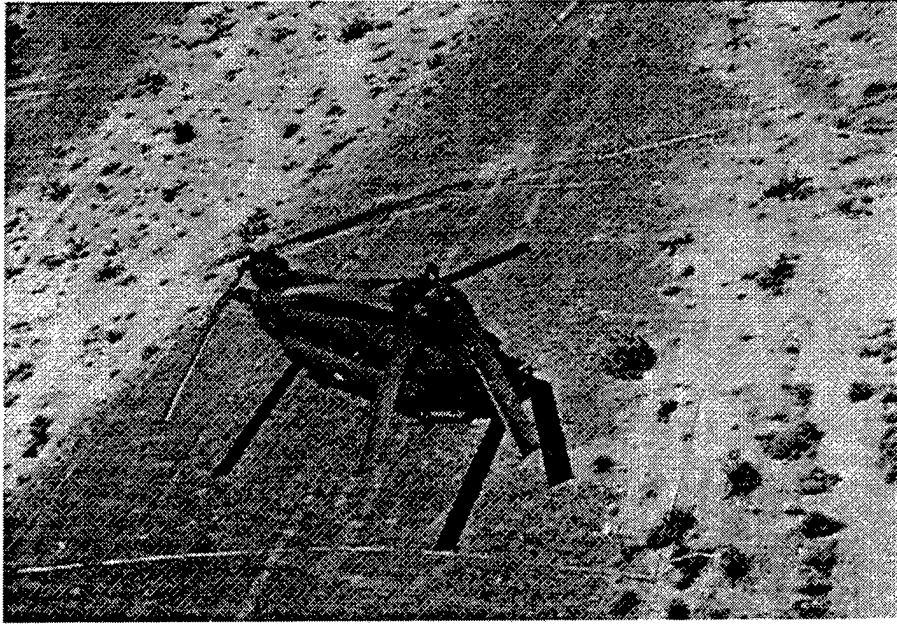
**Figure 1. Overhead View Showing the Damage Encountered by the Chinook Helicopter Subsequent to the Failure of the Blade Lag Shock Absorber (Photo Courtesy of CCAD).**

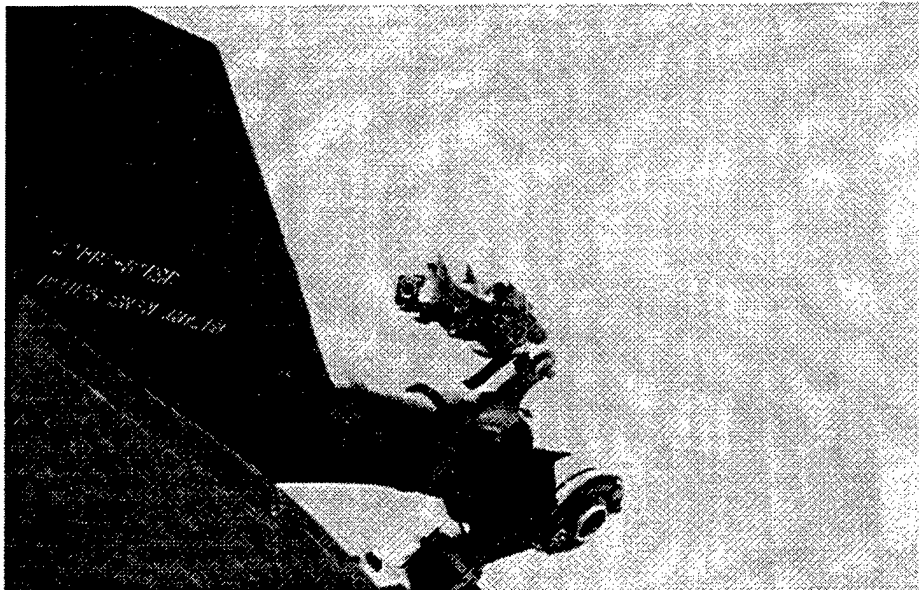
**Figure 2. View Showing the Extensive Damage at the Aft Rotor, Caused by the Blade Lag Failure (Photo Courtesy of CCAD).**

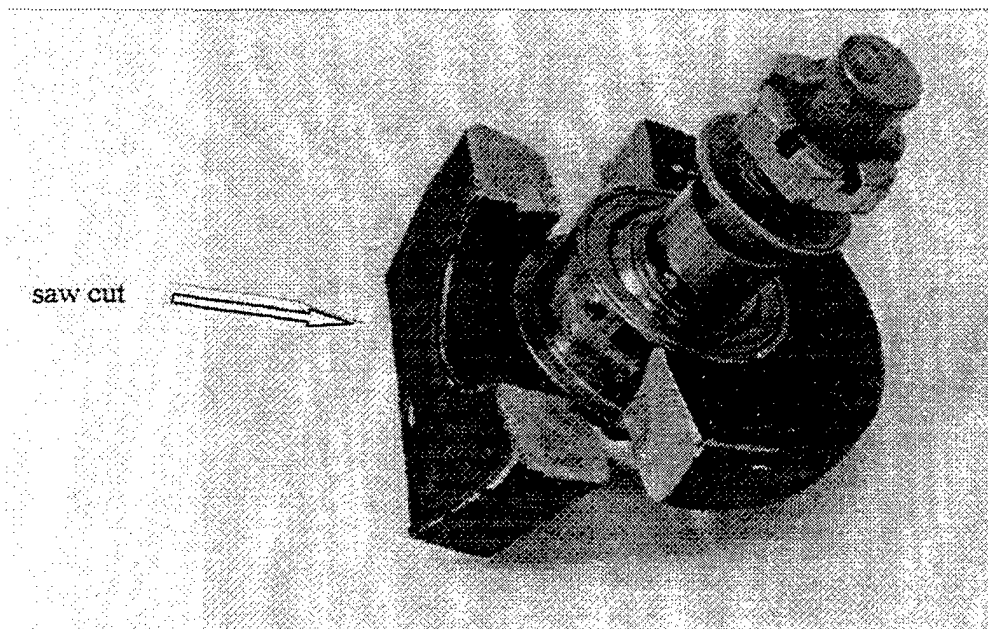
The failed part was visually examined at Boeing. The inboard lug had two radial through-fractures at the spherical bearing bore, as shown in Figure 8 [1]. The through-fractures were at the approximate positions shown in Figure 9 of the inboard lug of the blade lag shock absorber:

**Figure 8. Failed Component Taken From the Lag Blade Shock Absorber (Photo Courtesy of CCAD).**

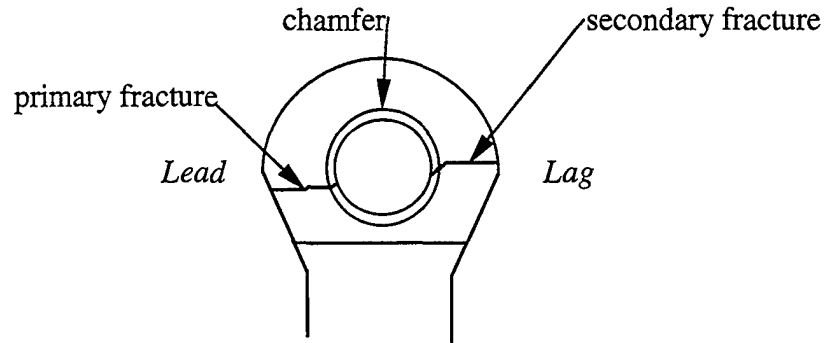
**Figure 9. Schematic Showing Positions of Through-Fractures.**

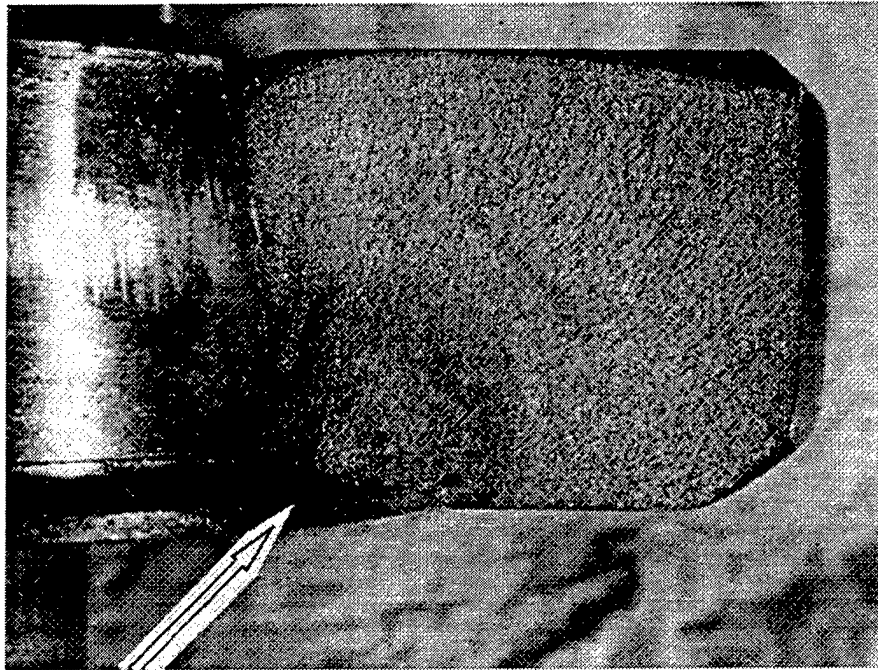
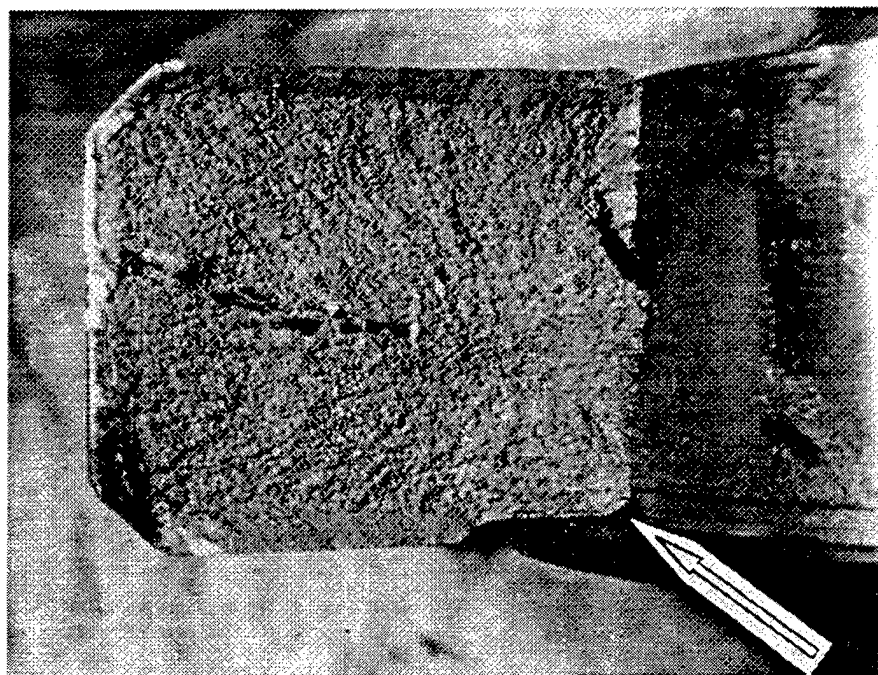
Fluorescent penetrant inspection performed by Boeing revealed no additional cracks. Figures 10 and 11 [1] show the primary and secondary fracture surfaces, respectively. The primary fracture (labeled as Fracture A within the context of this report) exhibited features consistent with a fatigue failure; the topography was relatively flat and smooth, with evidence of beach marks. The fatigue crack traversed approximately 95% of the fracture surface through the lead portion of the lug, while ductile shear lips comprised the remaining fracture surface. This was considered the primary fracture surface due to the extent of fatigue. The origin was determined to be located at the top of the 0.040-in, 45° chamfer. The secondary fracture (Fracture B) contained only approximately 20% fatigue through the lag region of the part, with the remainder exhibiting a ductile dimpled morphology. The origin of this fracture was determined to be located along the bore, approximately 0.05 in from the spot face of the lug. In addition, a dark-gold coating was observed along the exterior of the part. This coating was the typical color of a part that had been chromic-acid-anodized (as required in accordance with the engineering drawing). A blackish-green coating was observed on the bore surface, which was atypical of the chromic acid anodize. Finally, many axial score marks were noted on the bore surface. Some markings were shiny, while others contained the blackish-green coating. These markings were determined to be consistent with the prior removal of the bushing. The blackish-green coating and the axial score marks were evidence that the bore had been reworked.

**Figure 10. Optical Macrograph of the Primary Fracture (Photo Courtesy of CCAD).**

**Figure 11. Optical Macrograph of the Secondary Fracture (Photo Courtesy of CCAD).**

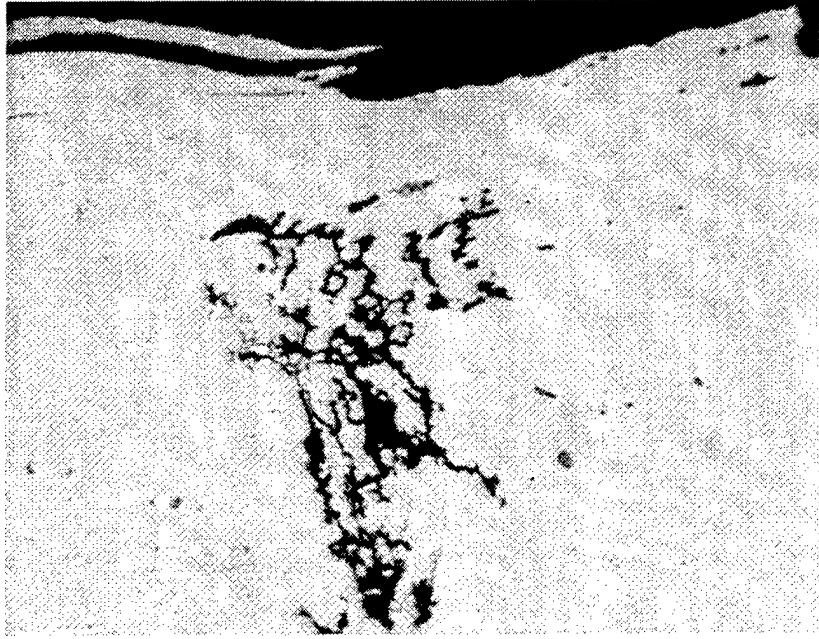
Boeing fabricated three transverse metallographic samples from the inboard lug. Evidence of intergranular attack was prevalent on each sample, extending along the bore wall and spot face of the lug. Figures 12 and 13 show examples of this corrosive attack in the as-polished condition, while Figure 14 shows another region of attack that had been etched with Keller's reagent. These areas of attack were located adjacent to the primary fracture. The average depth of the intergranular attack was approximately 0.010 in. The microstructure was examined in an effort to confirm that the part was properly aged to the -T73 condition. The major microstructural difference resulting from variations in time and temperature of -T73 tempers is the size and type of precipitate. However, these differences are subtle, and impossible to detect metallographically [6]. Moreover, transmission electron microscopy (TEM) is not adequate in distinguishing between these features. It is suggested within Davis [6] that the differences within a given temper (and between tempers) be established through hardness, conductivity and, in some cases, tensile yield results. The -T73 temper contains a mixture of  $\eta'$  and the stable, incoherent  $\eta$  ( $\text{MgZn}_2$ ) phase [7]. Figure 15 shows the precipitates of a sample sectioned through the chamfer in the as-polished condition. The light-gray particles were actually copper in color and represented the copper in the alloy. Figure 16 shows this structure etched with Keller's reagent at 200 $\times$  magnification. Note the directionality of the grains, indicative of the prior forming operation. Figure 17 shows this structure at higher magnification.

**Figure 12. Intergranular Attack Noted Along the Bore From a Sample Taken Adjacent to the Primary Fracture Surface; as Polished, Magnification 400 $\times$ .**

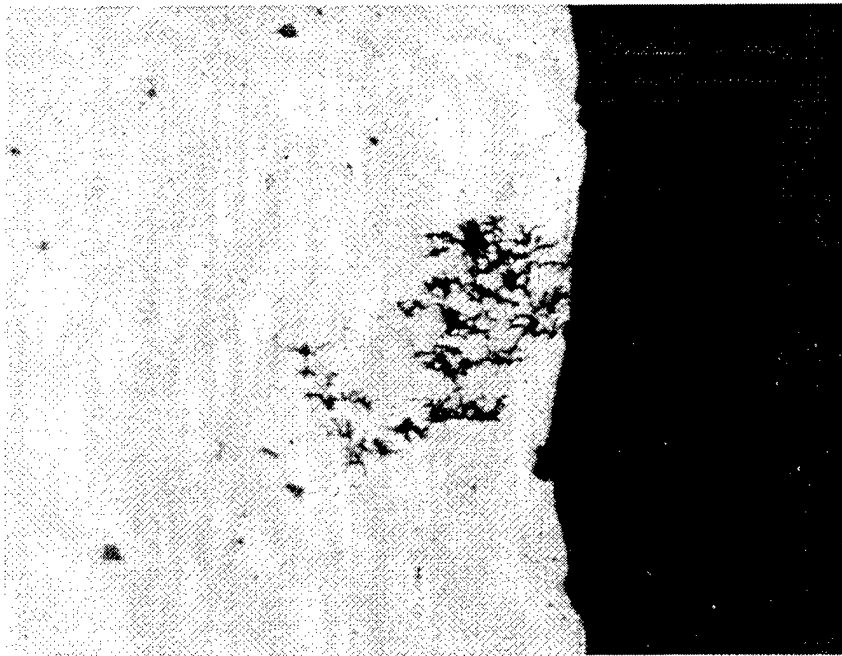
**Figure 13. Another Region of Intergranular Attack Noted Along the Bore From a Sample Taken Adjacent to the Primary Fracture Surface; as Polished, Magnification 200 $\times$ .**

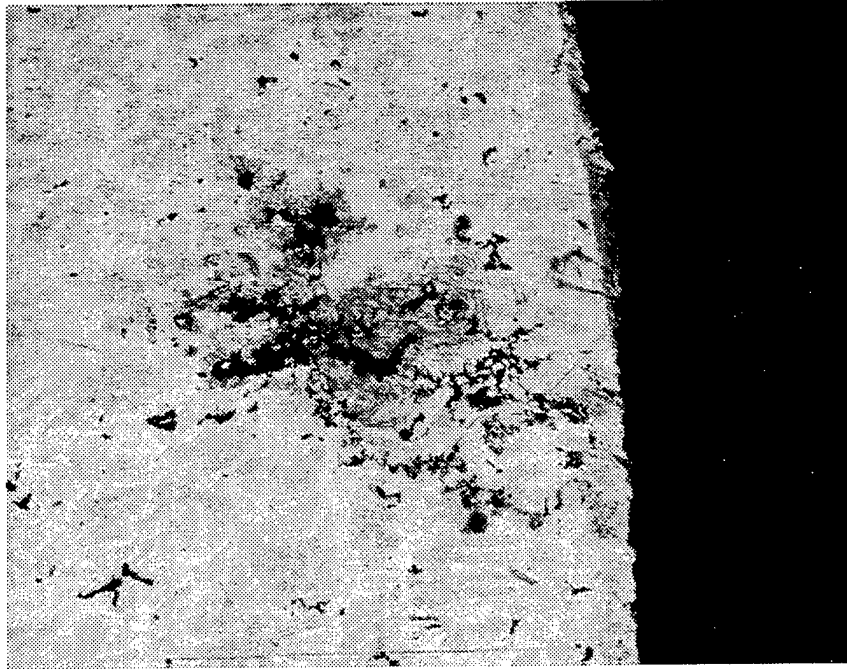
**Figure 14. Intergranular Attack Noted Along the Bore of a Sample Taken Adjacent to the Primary Fracture Surface; Keller's Etch, Magnification 200 $\times$ .**

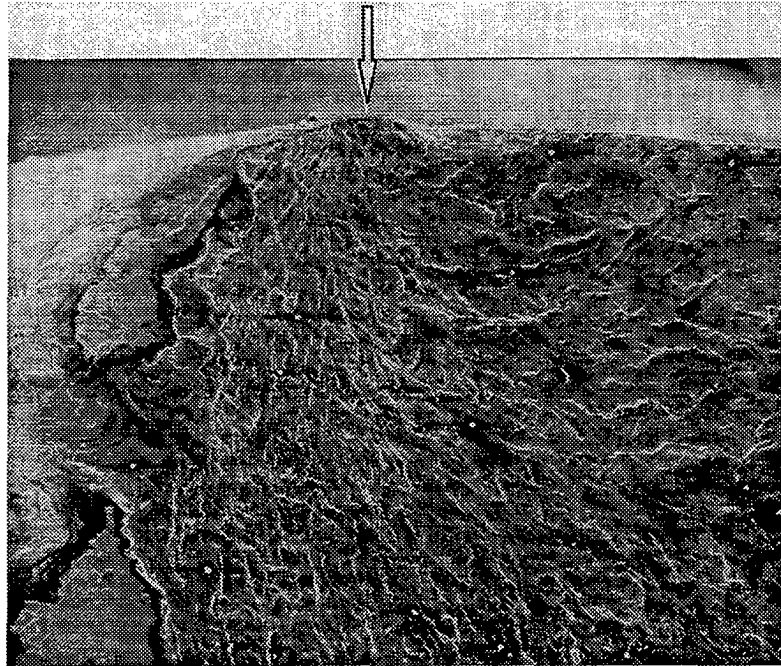
Boeing analyzed the fracture surfaces utilizing scanning electron microscopy (SEM). The results confirmed the origin locations, the fatigue failure mode, and the degree of fatigue crack propagation. Subsequently, ARL examined the fracture surfaces to more fully document the findings. The origin of the primary fracture is shown in Figure 18. The radial lines converge at the origin on the surface. Figure 19 shows the origin at an angle such that the bore can be seen,

**Figure 18. SEM Macrograph of the Primary Fracture Origin (Indicated by Arrow); Magnification 50 $\times$ .**

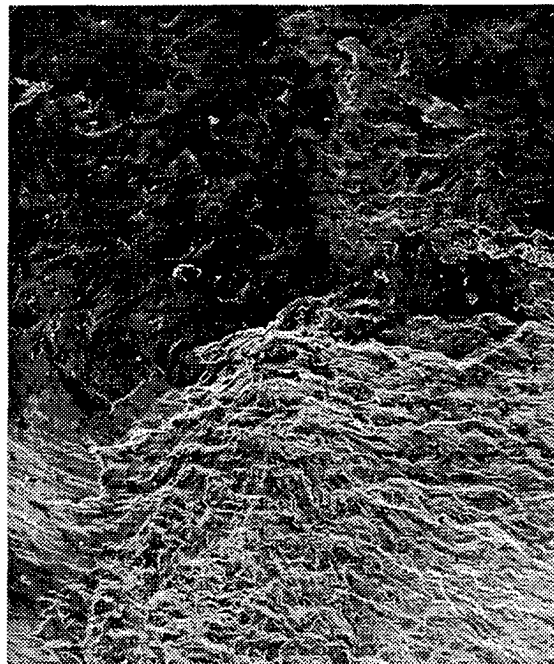
**Figure 19. SEM of the Fracture Origin of the Primary Fracture, Tilted at an Angle to Reveal the Surface of the Bore; Magnification 50 $\times$ .**

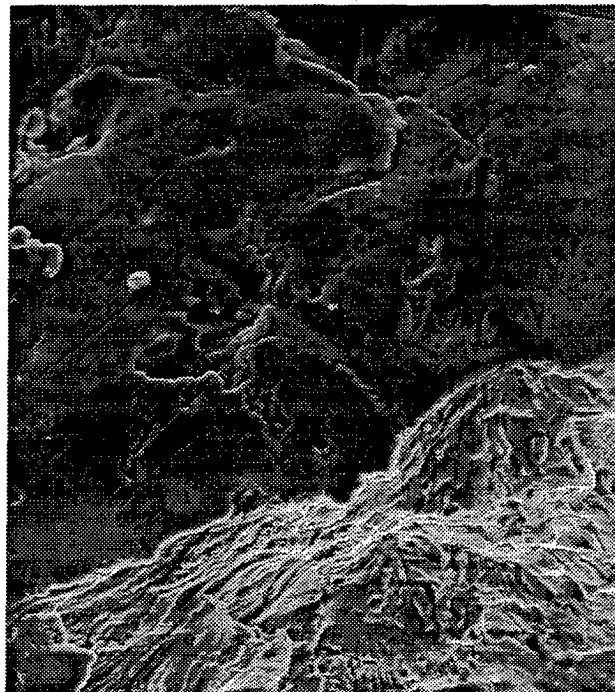
while Figure 20 is a magnification of this area showing intergranular surface attack adjacent to the origin. Beyond the fracture region, a small shear lip consisting of ductile dimples was observed, which represented final fracture. No inherent defects or gross inclusions were noted at the origin of the primary fracture. The topography of the secondary fracture was characterized by a smaller region of fatigue, with the remainder of the surface typical of overload. The fatigue morphology was characterized by a shiny appearance, in contrast to the overload region that displayed a dull texture. A shear lip encompassed the outer periphery of the fracture surface, except for the bushing wall. An intergranular morphology was evident at the fracture origin. Figure 21 shows the origin of the secondary fracture. The origin at an angle is shown in Figure 22. Figure 23 shows intergranular surface attack adjacent to the origin. EDS examination of the dark golden colored coating at Boeing revealed a level of chromium consistent with a chromic acid anodize.

**Figure 20. Magnified SEM of Figure 19, Showing Intergranular Attack on the Surface of the Bore Adjacent to the Primary Fracture Origin; Magnification 200x.**

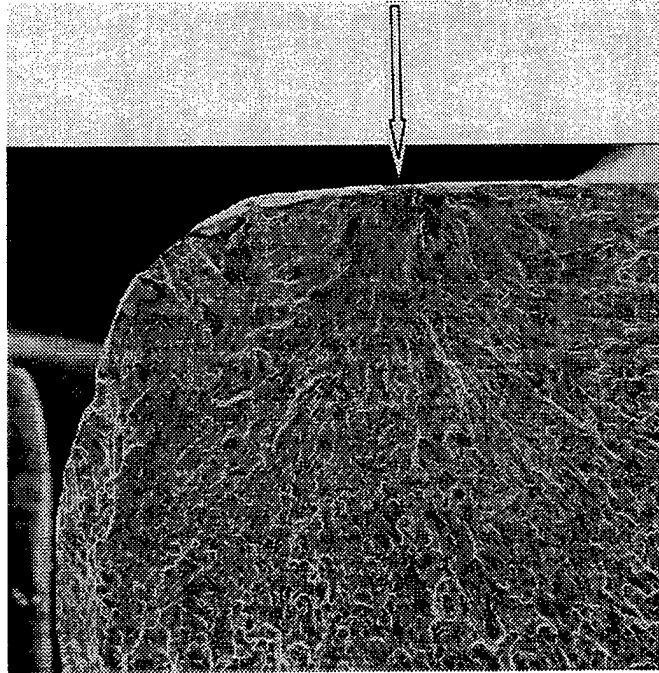
**Figure 21. SEM of the Secondary Fracture Origin (Indicated by Arrow); Magnification 50 $\times$ .**

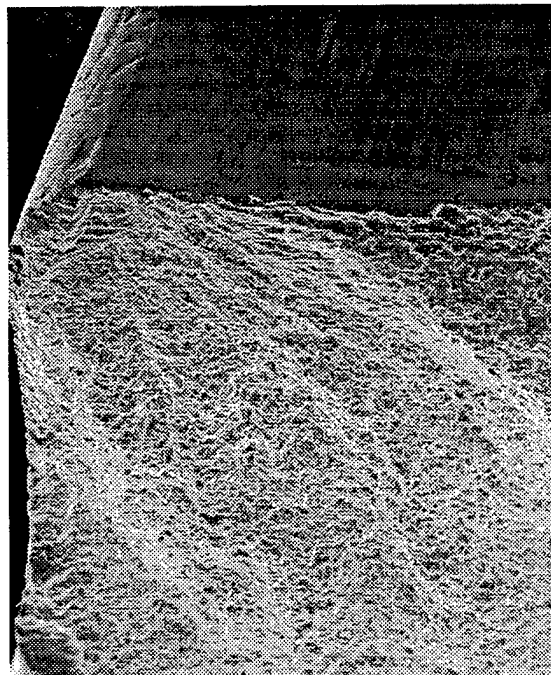
**Figure 22. SEM of the Secondary Fracture Origin, Tilted at an Angle to Reveal the Surface of the Bore; Magnification 50 $\times$ .**

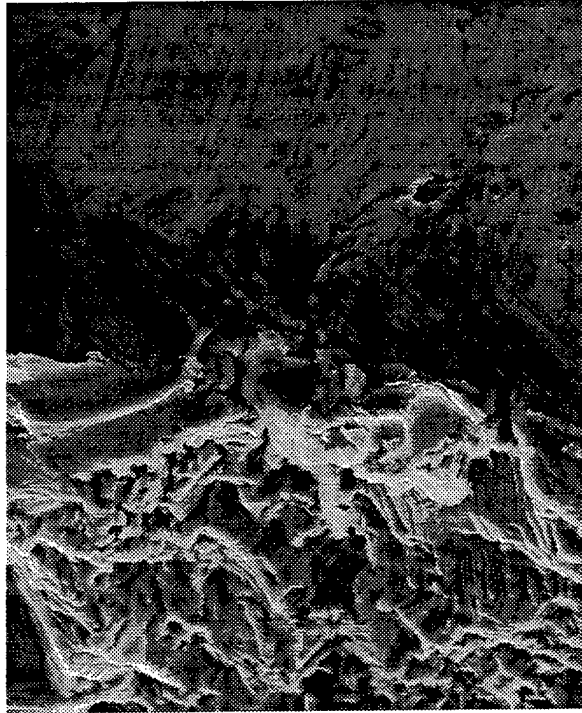
**Figure 23. Magnified SEM of Figure 22 Showing Intergranular Attack on the Surface of the Bore Adjacent to the Secondary Fracture Origin; Magnification 500 $\times$ .**

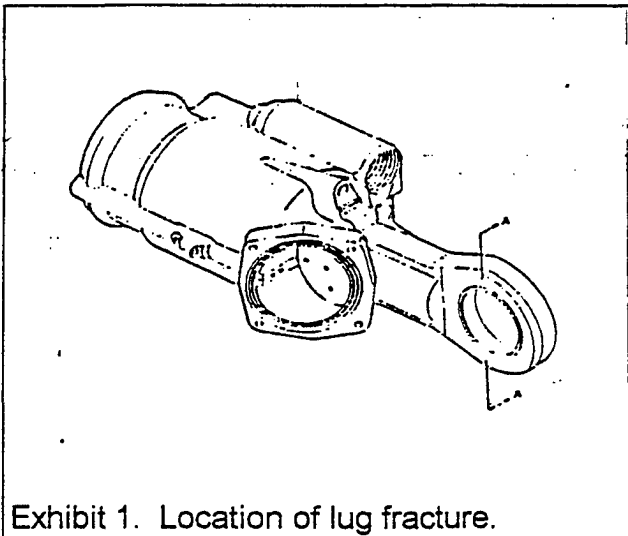
1. The lug fracture occurred essentially perpendicular to the longitudinal axis of the blade lag shock absorber (Exhibit 1, Arrows A-A).

Exhibit 1. Location of lug fracture.

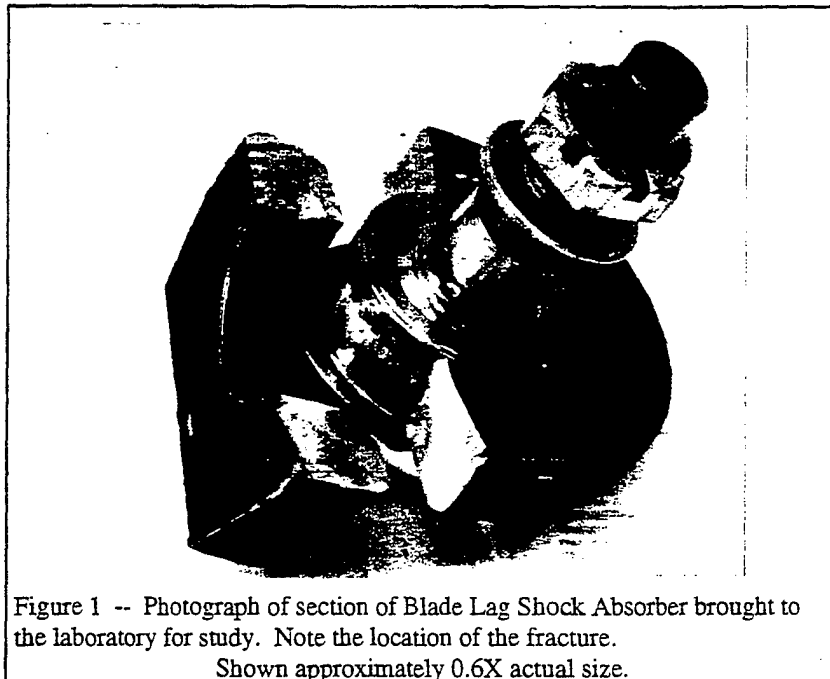
The portion of the Blade Lag Shock Absorber housing where fracture occurred was removed from the remainder of the part and brought to the laboratory for study. Fracture occurred approximately one eighth inch from the center line of the bore containing the uniball bearing (where the Shock Absorber is attached to the Rotary Head) and was approximately 90° to the length of the housing. The bearing, with attached hardware (bushing, bolt, etc.) remained attached to the larger section which fractured from the housing. See Figure 1.

Figure 1 -- Photograph of section of Blade Lag Shock Absorber brought to the laboratory for study. Note the location of the fracture.

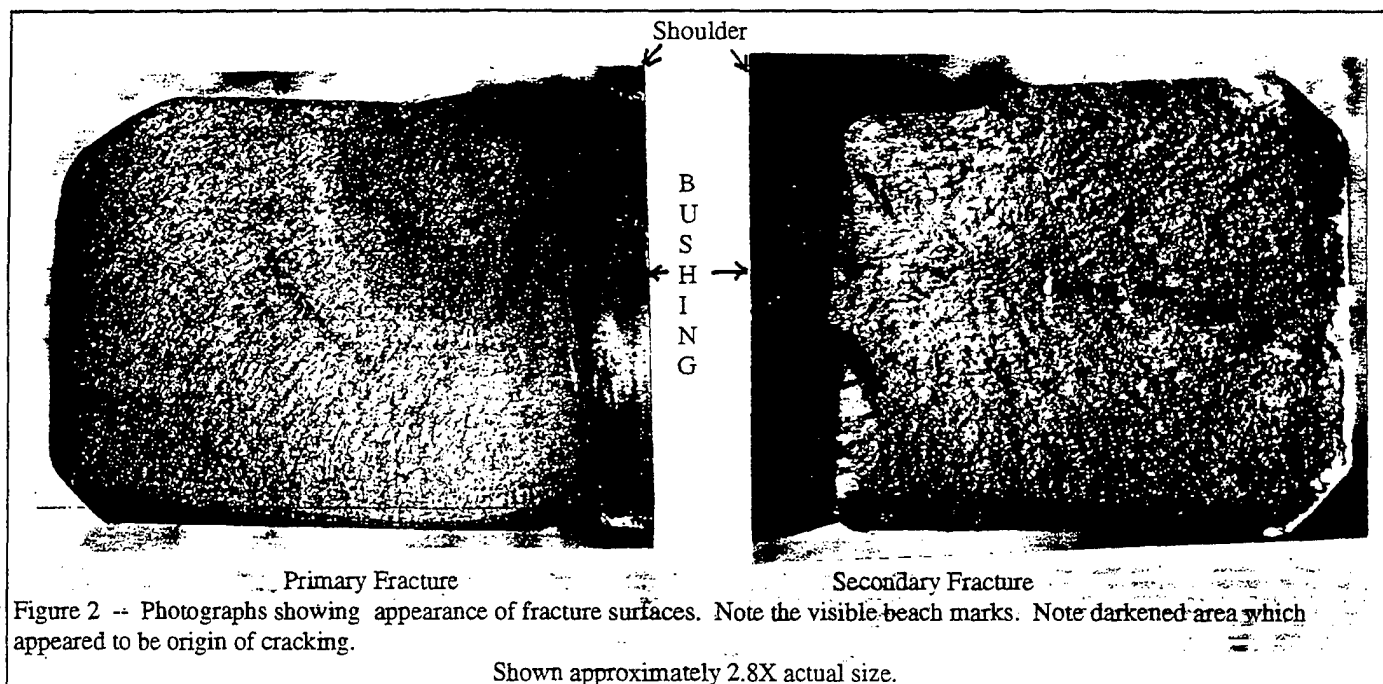
Inspection of the fracture surfaces (to both sides of the bearing) revealed yellow to brown coloration near the chamfered edge located on the top side (positioned under the shoulder of the bushing) of the bore. The coloration was much more pronounced on one fracture suggesting this fracture occurred first (hereafter referred to as the primary fracture). Beach markings, indicative of fatigue damage, appeared to have originated at, or near, the chamfered edge of this fracture. The beach markings were visible on approximately 75% of the fracture surface. Inspection of the second fracture (hereafter referred to as the secondary fracture) revealed a coarse texture suggesting this failure was primarily due to overstress. See Figure 2.

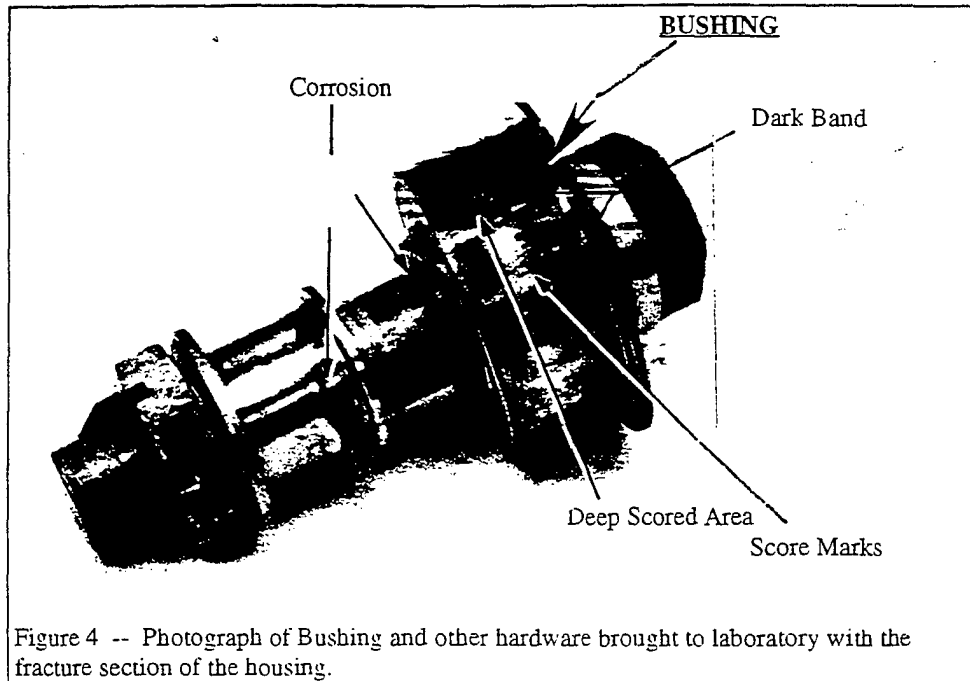
The outer surface of the bushing (which mates with the bore in the housing) was also inspected at magnifications to 30X. See Figure 4. These inspections revealed the following.

\*\*\* Evidence of corrosion to the other associated hardware (bolt, nut, etc.).

Figure 4 -- Photograph of Bushing and other hardware brought to laboratory with the fracture section of the housing.

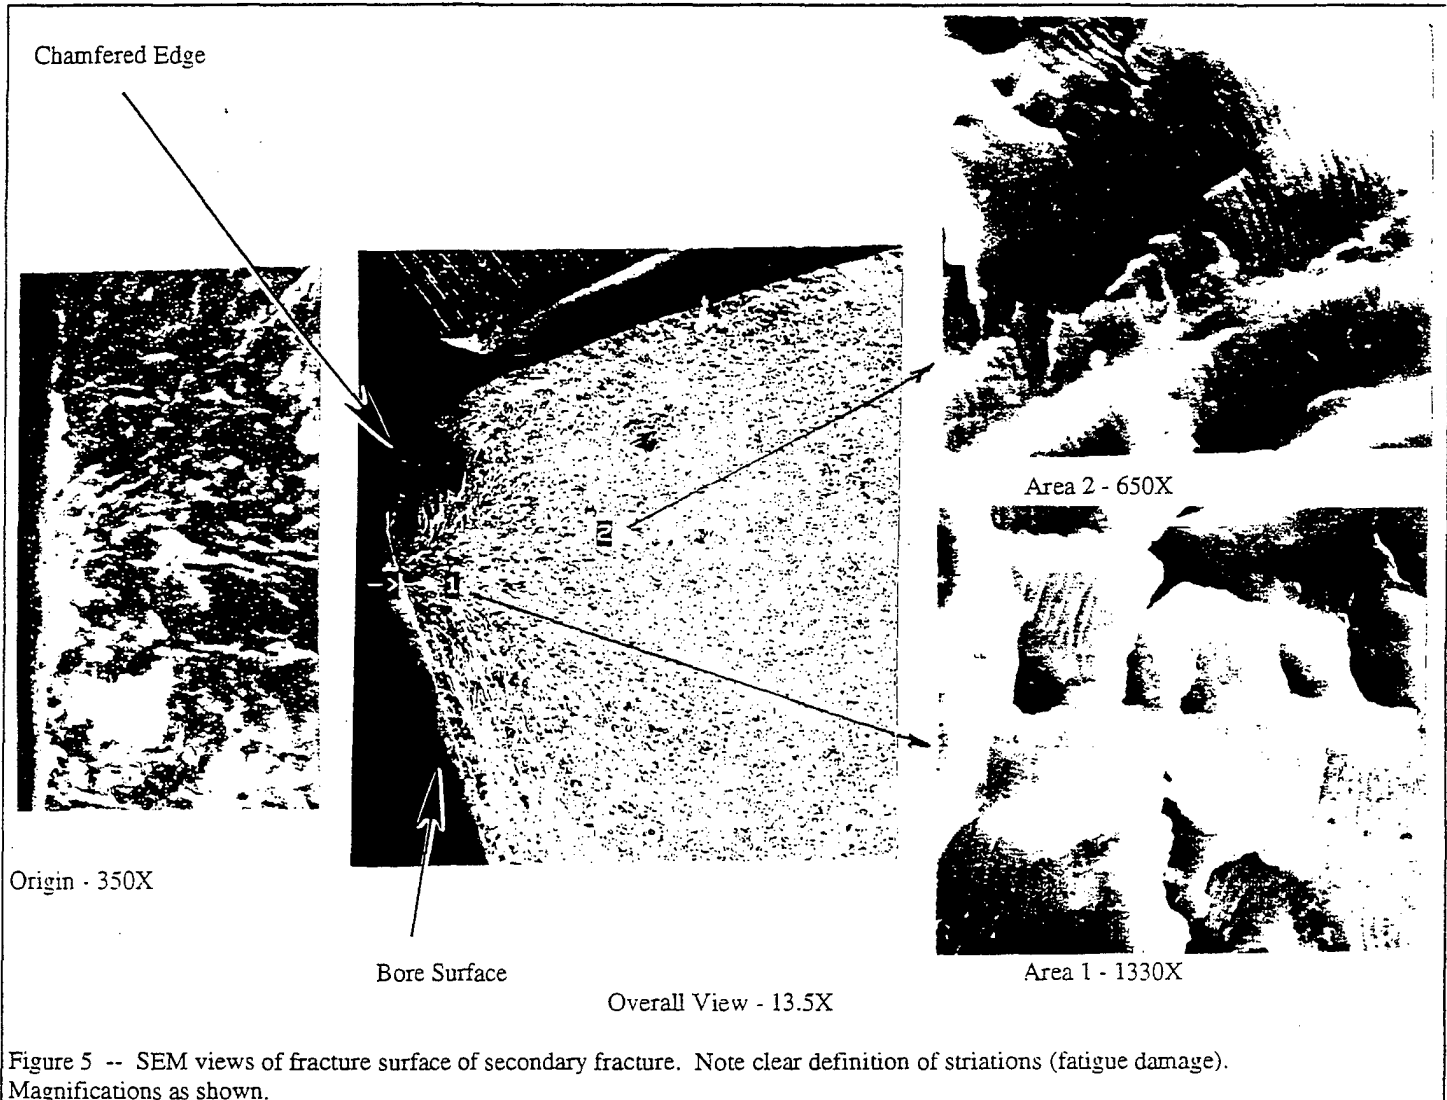
\*\*\* Striations were visible to approximately one-fourth inch from the chamfered edge defining that the cracking was propagated due to cyclic stress. The remainder of the fracture topography was indicative of that resulting from overstress.

Figure 5 -- SEM views of fracture surface of secondary fracture. Note clear definition of striations (fatigue damage). Magnifications as shown.

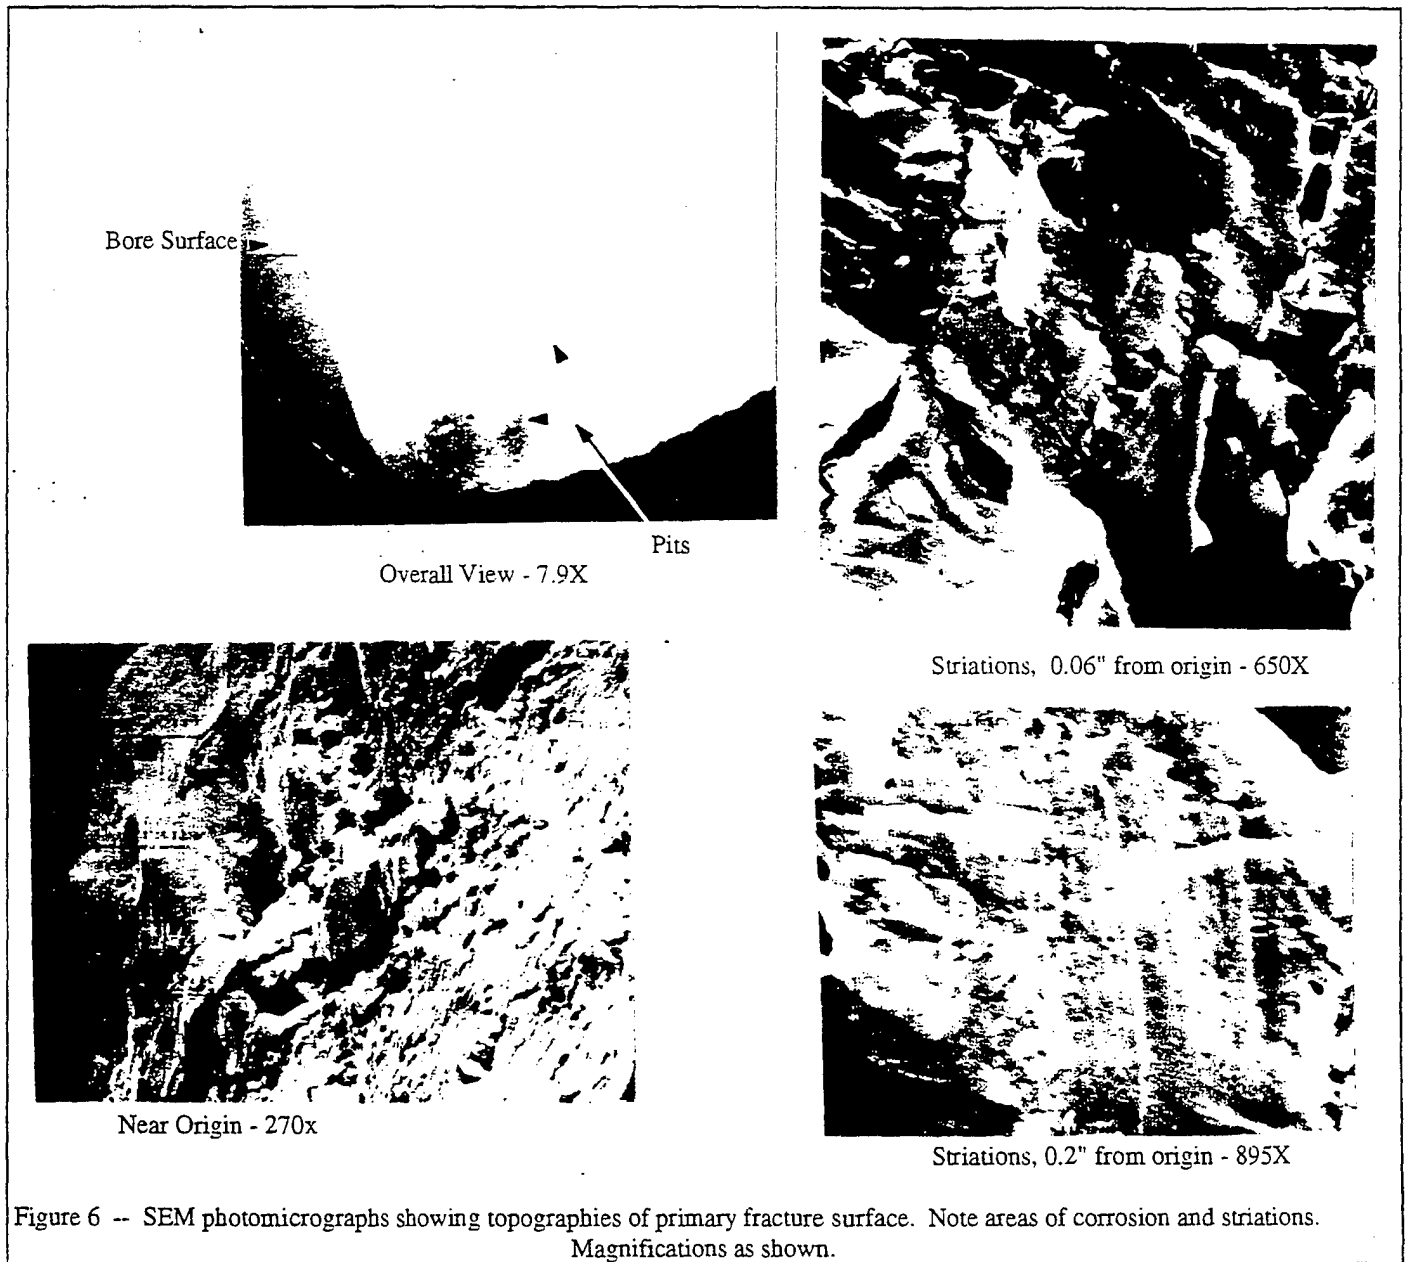
\*\*\* The striations, clearly visible at magnifications to 1000X, were present on 80-90% of the fracture surface. The final fracture, located on the diametrical opposite corner of the fracture surface, had a topography indicative of overstress.

Figure 6 -- SEM photomicrographs showing topographies of primary fracture surface. Note areas of corrosion and striations. Magnifications as shown.

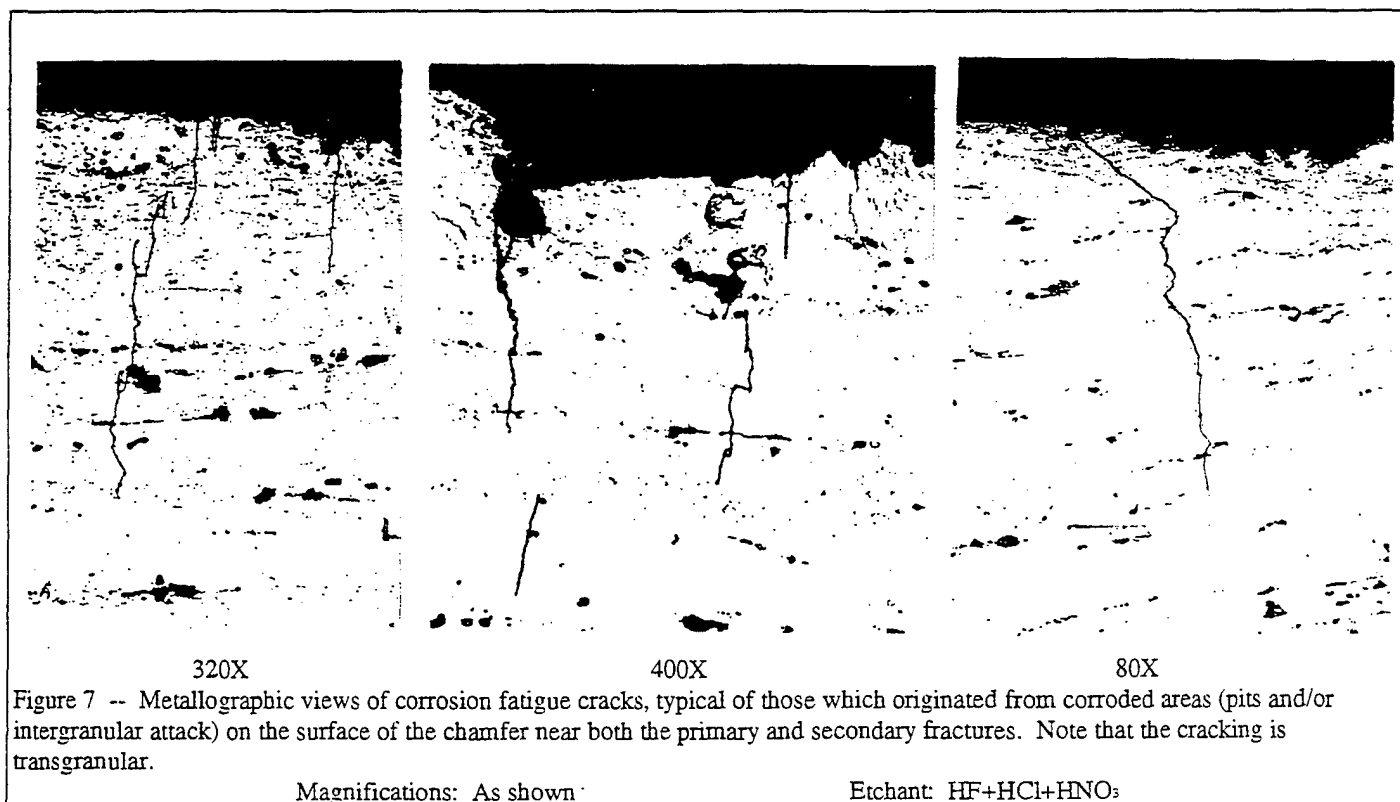
\*\*\* Some secondary cracks from the fracture surfaces. These cracks were small and transgranular.

Figure 7 -- Metallographic views of corrosion fatigue cracks, typical of those which originated from corroded areas (pits and/or intergranular attack) on the surface of the chamfer near both the primary and secondary fractures. Note that the cracking is transgranular.

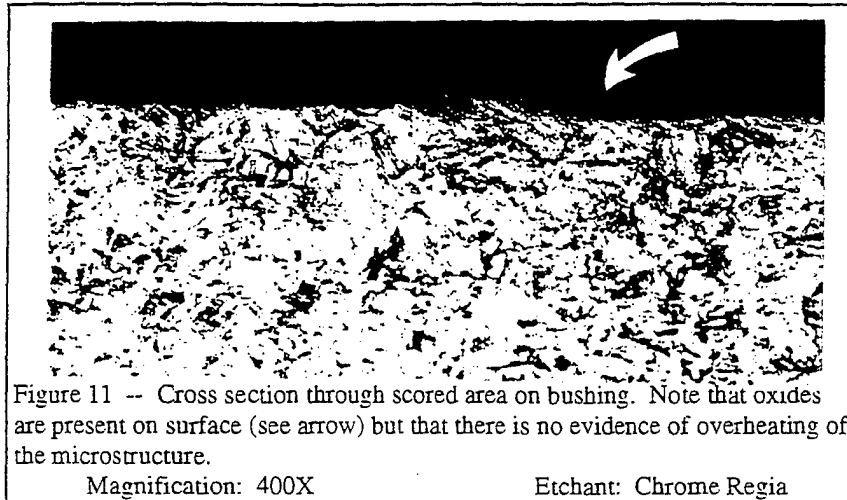
The bushing was sectioned through the scored areas. Although oxides were present in the area of the deep score marks, there was no evidence of overheating ("burning" as could result from use of a grinding wheel) in the microstructure below the scored areas. See Figure 11.

Figure 11 -- Cross section through scored area on bushing. Note that oxides are present on surface (see arrow) but that there is no evidence of overheating of the microstructure.

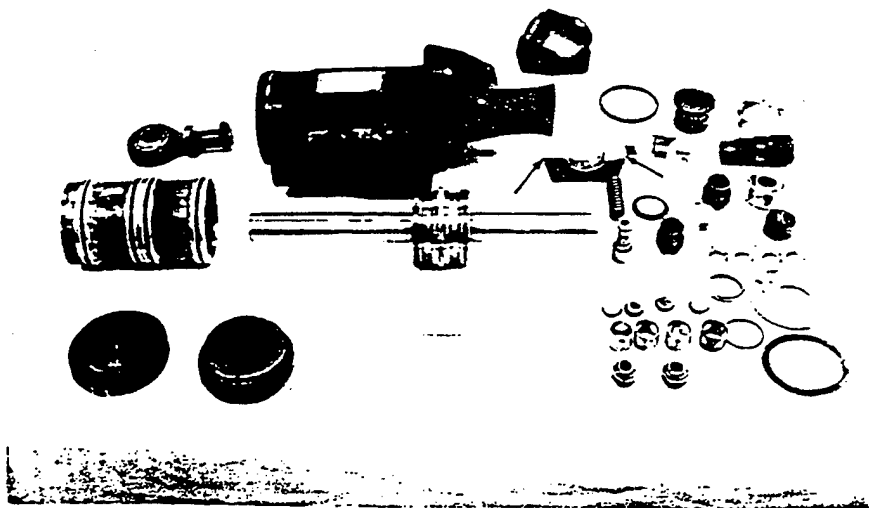
Figure 2 0.1X  
As-received photograph of the Blade Lag Shock Absorber, P/N 114H6800-5, S/N VY1313. Arrows denote inboard lug fracture surfaces.

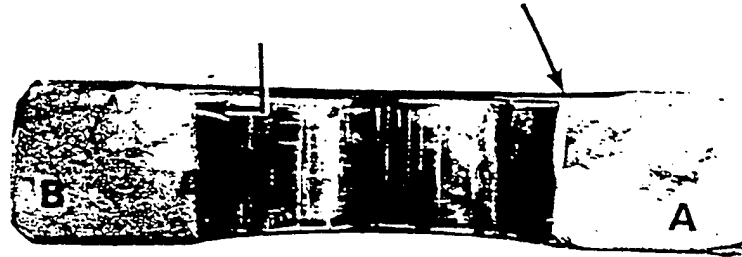
Figure 3 1X  
Photograph of the through fractured inboard lug displaying fatigue fracture surfaces A (primary) and B (secondary). Arrows indicate approximate origin locations.

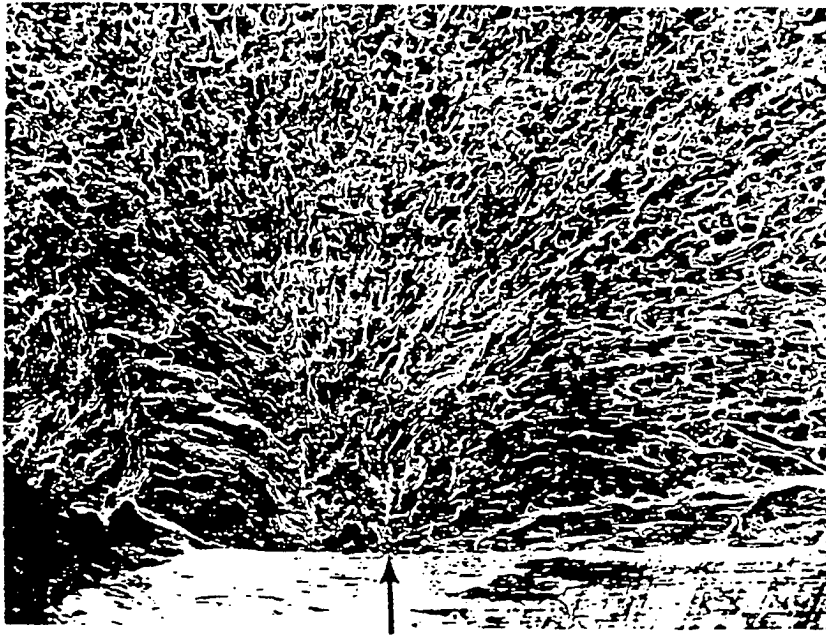
Figure 8 50X  
SEM photograph of the secondary fracture surface B . Arrow  
denotes the origin location.

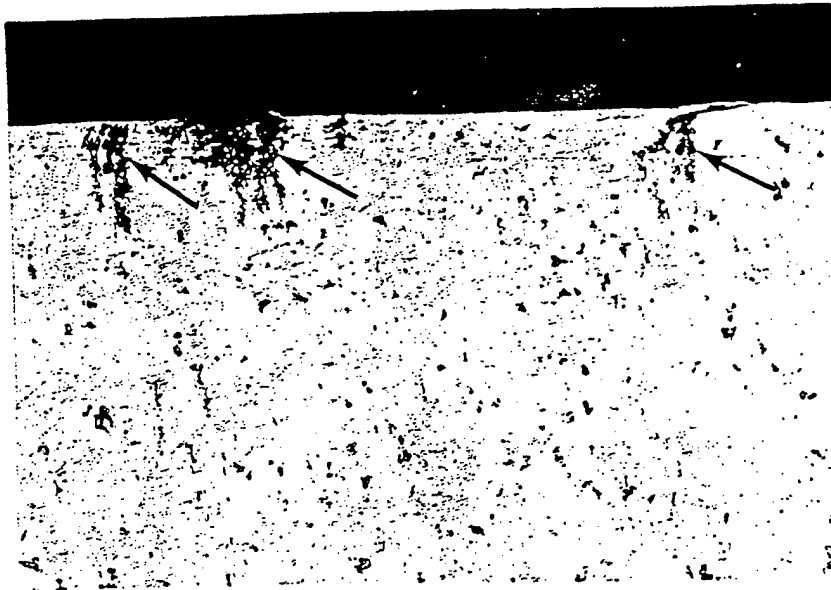
Figure 12 100X  
Photomicrograph of a cross-section through the lug approximately 90°  
from the primary origin, revealing intergranular corrosive attack (arrows)  
extending from the bore surface.

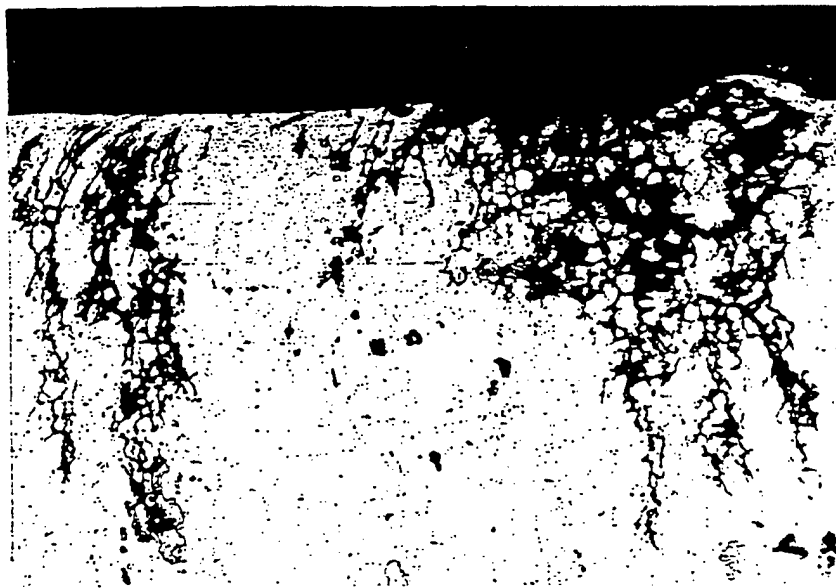
Figure 13 400X  
Magnified view of the cross-section through the lug bore revealing  
intergranular attack extending to an approximate depth of 0.006 inch.

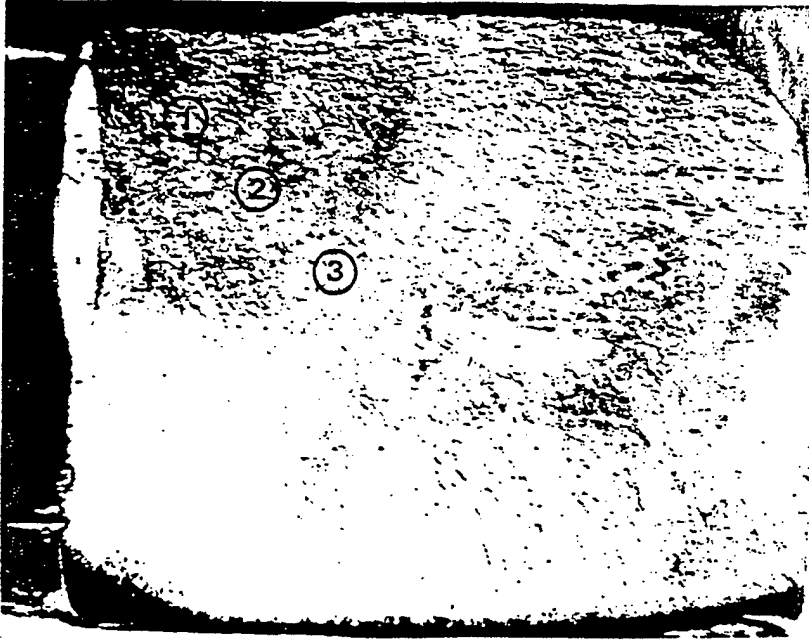
Figure 14 4X  
Photograph of the primary fracture surface. Areas ①, ② and ③ denote locations where measurements were obtained for fatigue striation spacing determination.
