**Failure Analysis of a CH-47 Horizontal Hinge Pin  
Assembly, P/N 114RS226**

by Marc Pepi and Gary Wechsler

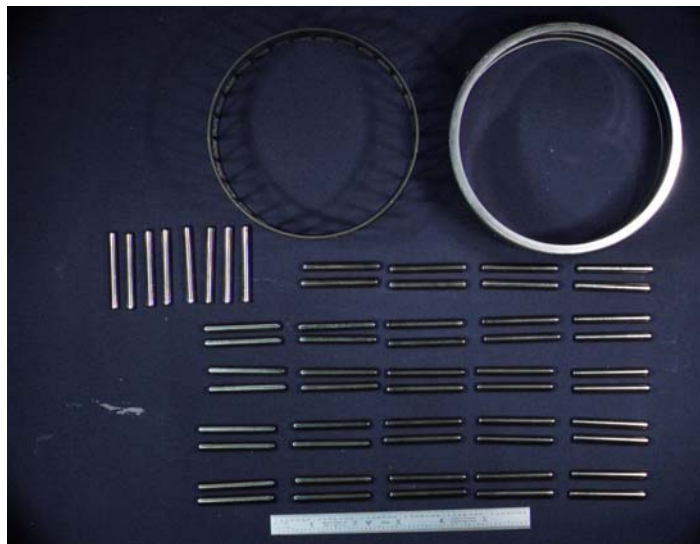
Figure 1. The rollers, cage, and sleeve of the lead roller bearing set. The scale is 6 inches in length.

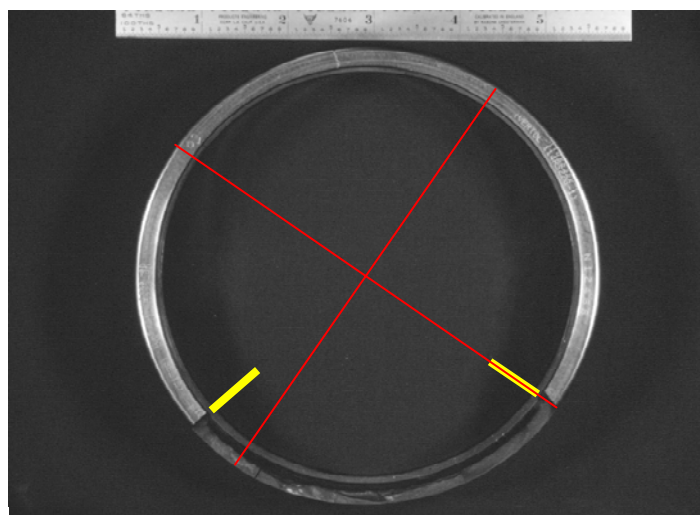
Figure 2. View of the lag ring showing that the fractured region encompassed an approximately 4-in arc length of the ring’s circumference.

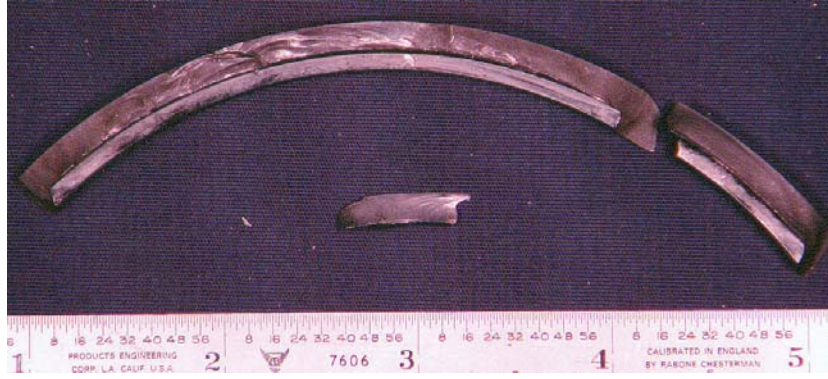
Figure 3. Three pieces of material that fractured from the lag ring depicted in figure 2.

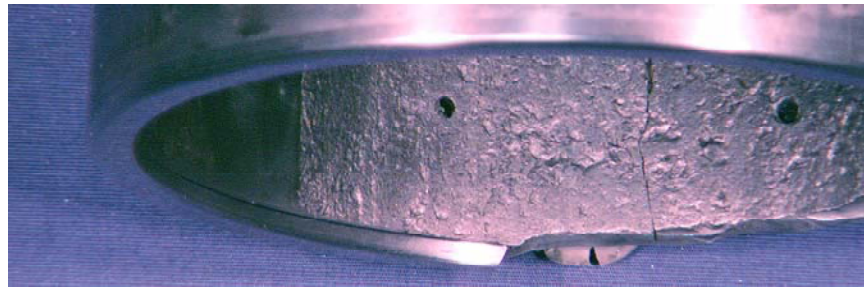
Figure 4. The lag-ring raceway exhibited a spalled surface topography. Fracture and cracking were relegated to the portion of the lag ring exhibiting a spalled raceway surface.

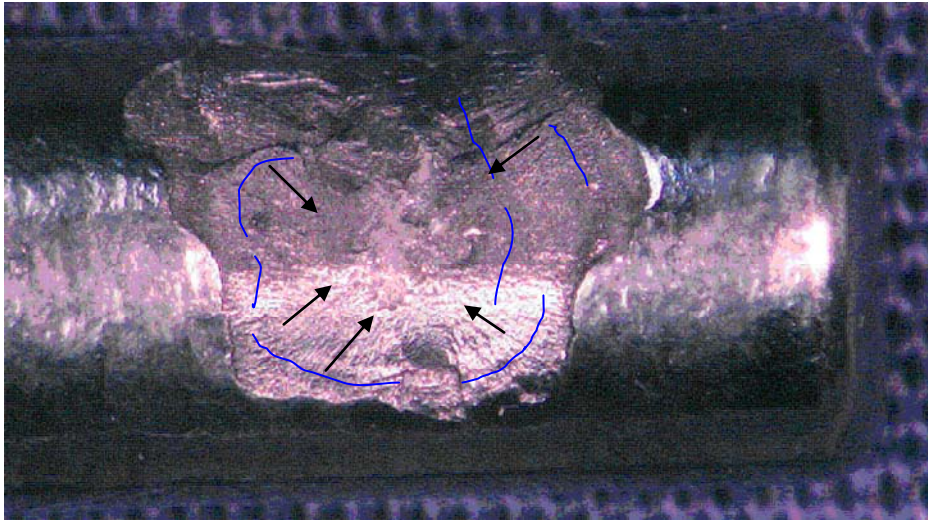
Figure 6. Typical surface damage and spalling exhibited on the lag rollers. The topography of the surface created by spalling exhibited the beach marks (parallel with the blue lines) and river patterns (parallel with the black arrows) indicative of subsurface crack initiation and propagation by RCF. Magnified  $\sim 5.7\times$ .

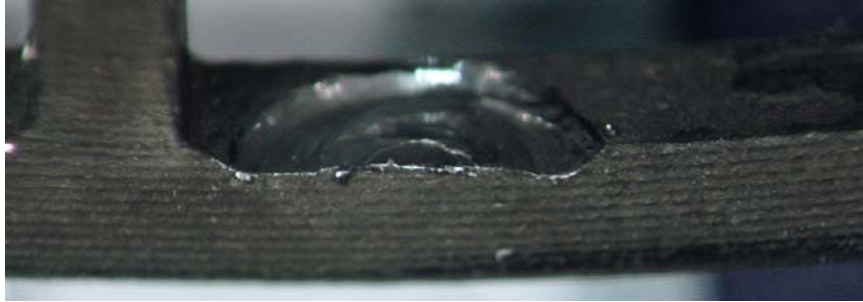
Figure 8. Inner surface of the lag retainer exhibiting wear damage caused by contact with the mating rotating roller—indicative of high contact loads between the two parts. Magnified 9.7 $\times$ .

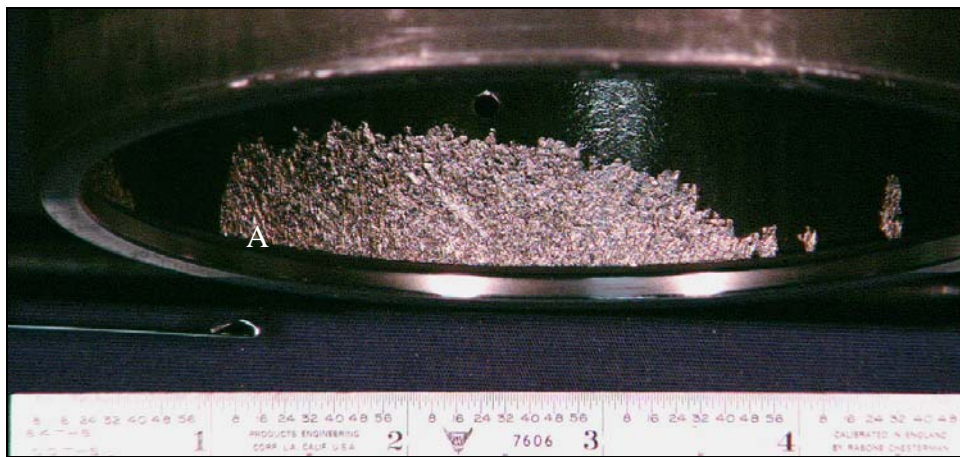
Figure 9. Lead-ring raceway spalling.

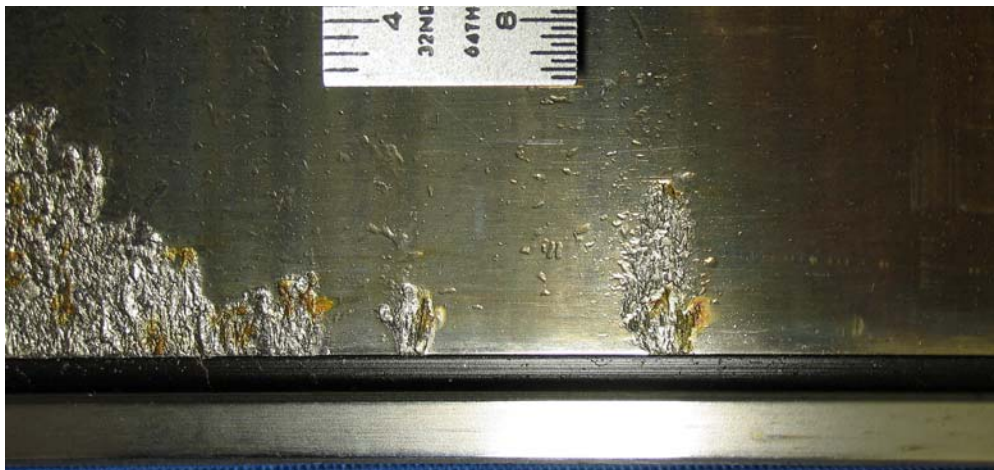
Figure 10. Lead-ring raceway spalling likely began by the edge of a groove.

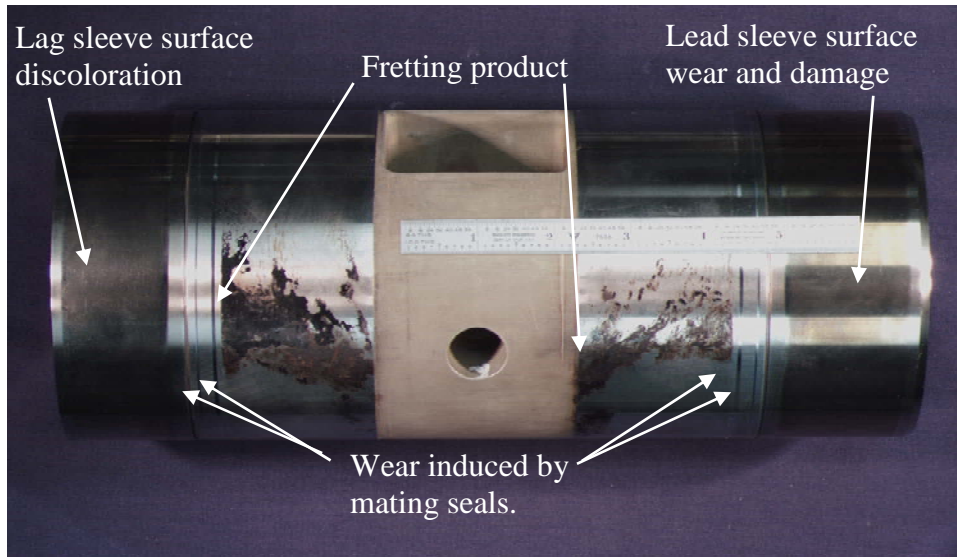
Figure 11. The HHP in the as-received condition exhibited discolored lead-sleeve and lag-sleeve raceways. The chrome-plated surface of the HHP between the sleeves exhibited wear induced by mating seals and fretting product created by the relative motion between the HHP and a mating pitch-shaft sleeve.

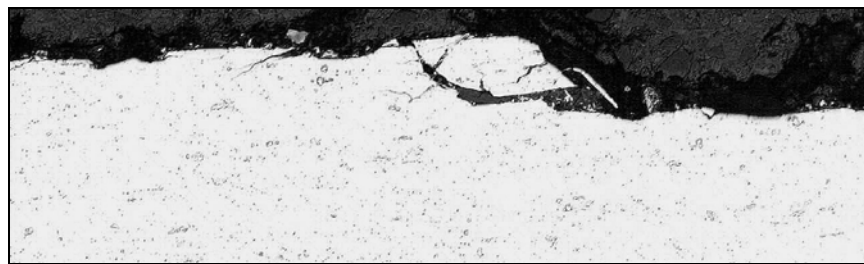
Figure 12. Micrograph of an as-polished section cut from the spalled portion of the lag-ring raceway. No microstructural anomalies were observed. Magnified 200 $\times$ .

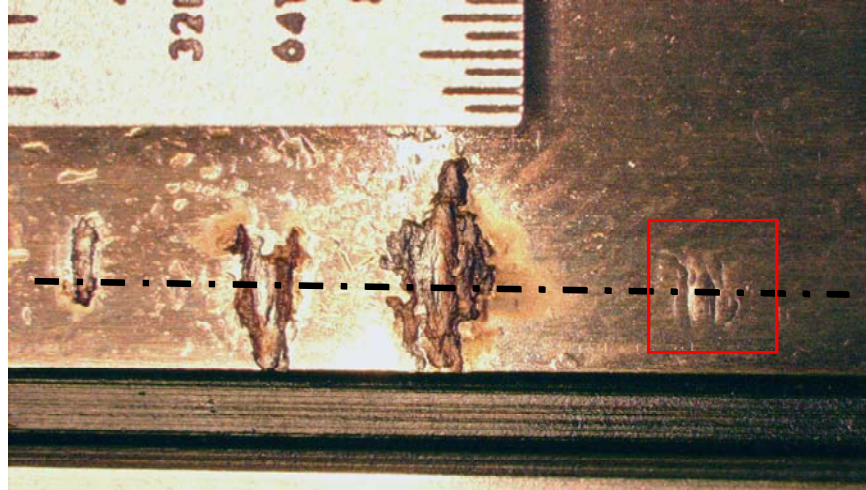
Figure 13. Spalling and cracking on the raceway of the lead ring. Dashed line represents section made for metallographic examination.

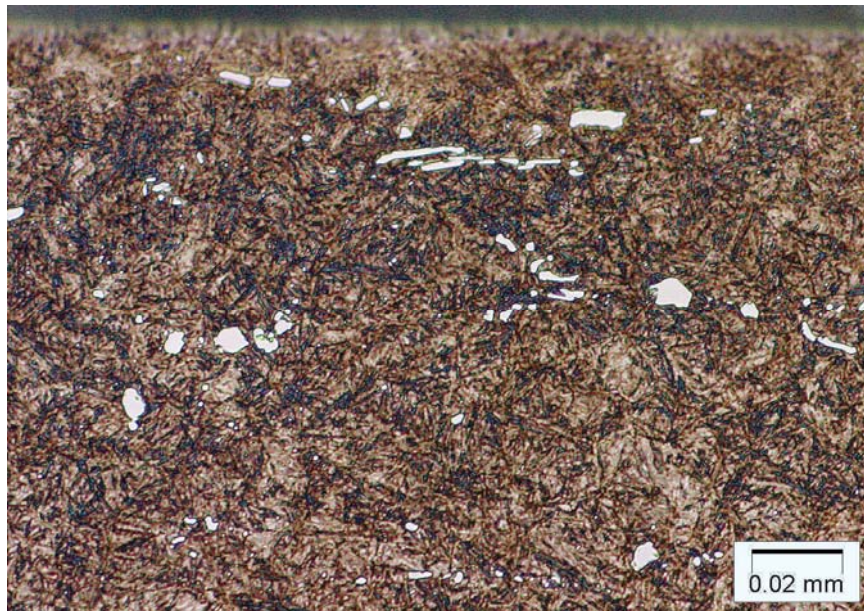
Figure 18. Microstructure of the lead ring exhibiting the carbides (both acicular and globular) dispersed in a matrix of tempered martensite observed in all the metallographic cross sections produced from the M50 steel rings and rollers. Etchant: Vilella's reagent.

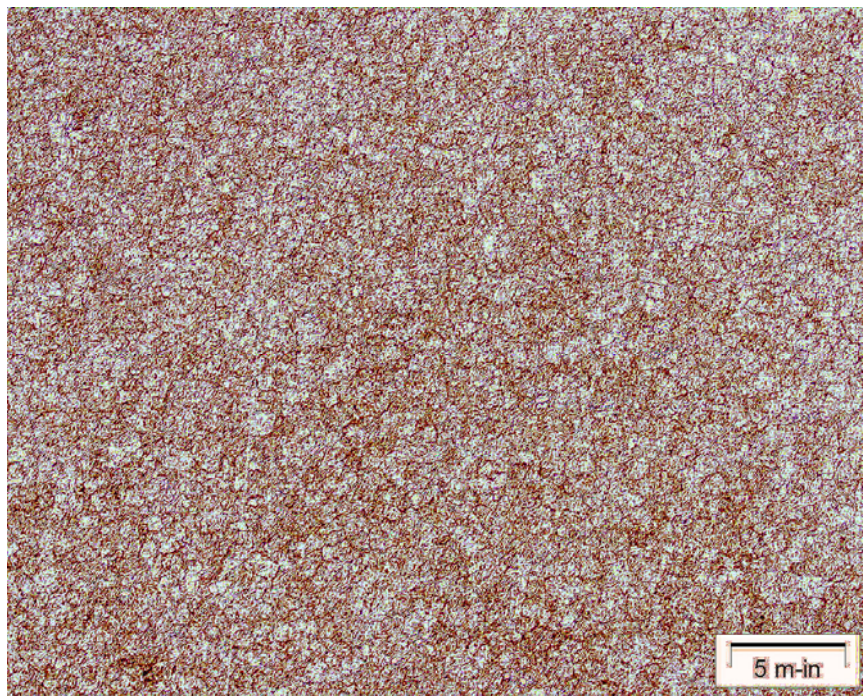
Figure 19. Micrograph of the lag-ring microstructure showing a grain size that conformed to the required average ASTM grain size no. 8 or finer, with occasional grains as large as ASTM grain size no. 6. Etchant: Vilella's reagent. Magnified 100×.

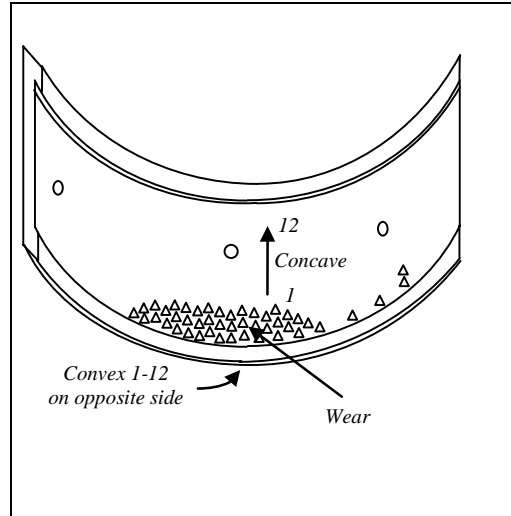
Figure 20. Schematic showing location of hardness readings on lead-ring sample, adjacent to wear (see table 3).

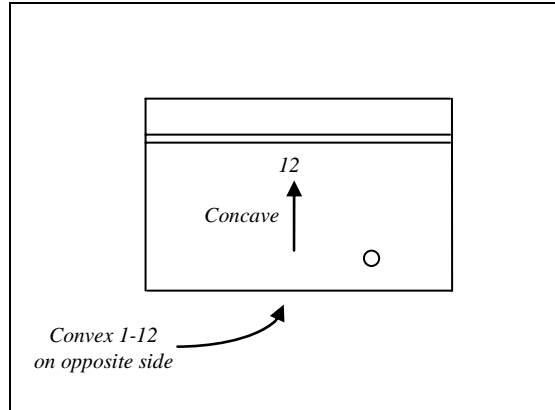
Figure 21. Schematic showing location of hardness readings on lead-ring sample away from wear (see table 4).

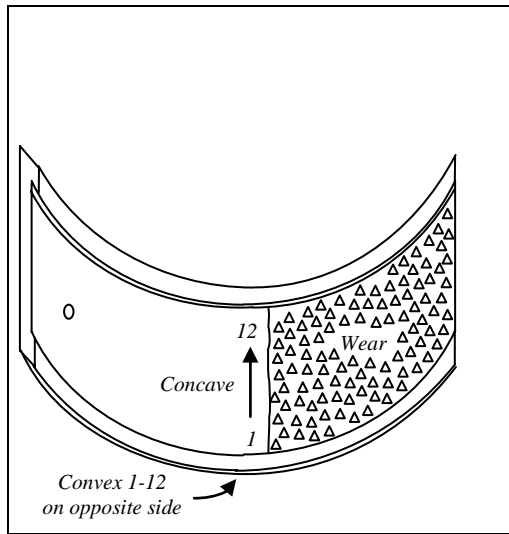
Figure 22. Schematic showing location of hardness readings on lag-ring sample, adjacent to wear (see table 5).

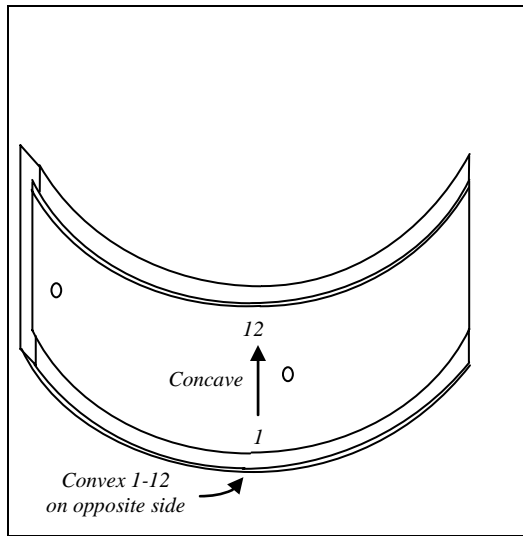
Figure 23. Schematic showing location, of hardness readings on lag-ring sample away from wear (see table 6).

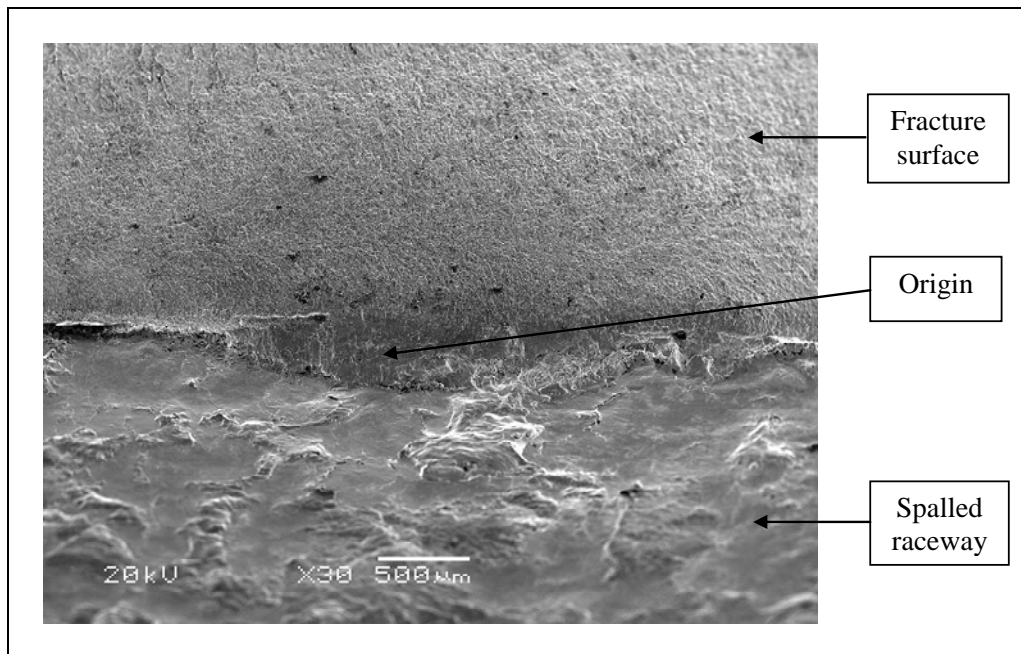
Figure 24. One of the fracture origins on the surface of the lag ring (identified via light-optical microscopy and labeled with the nomenclature A in figure 13).

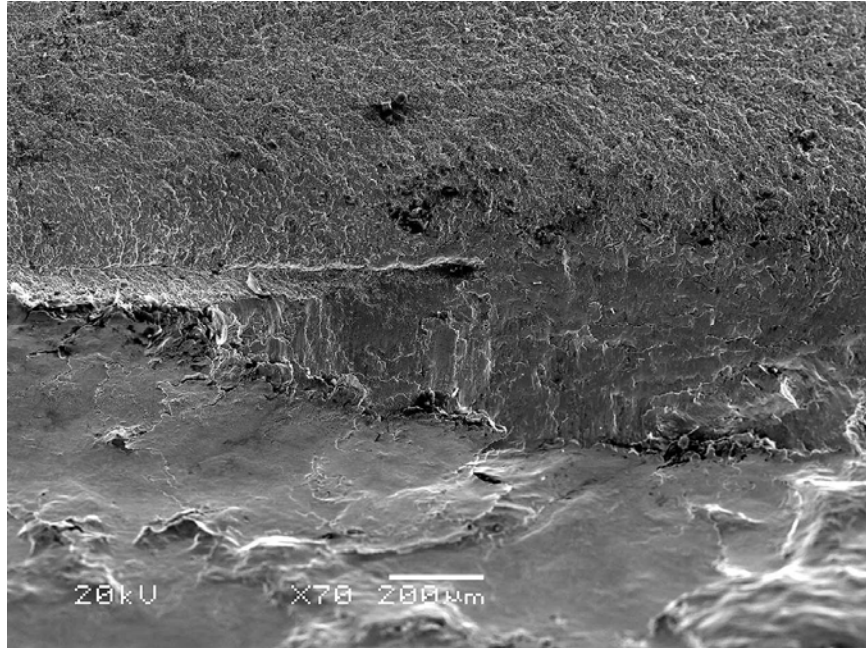
Figure 25. Detail view of the origin shown in figure 24 showing that the topography of the origin is smeared.

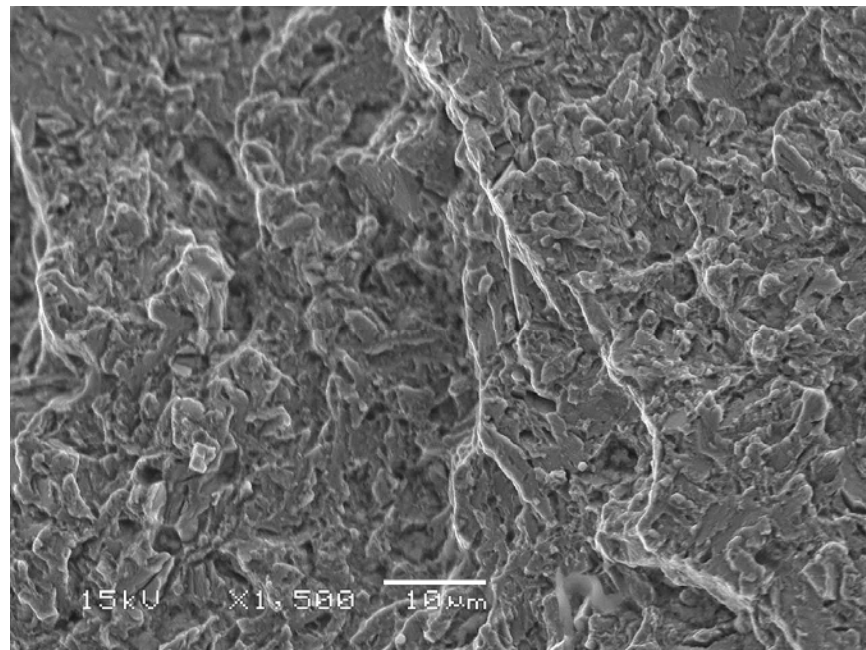
Figure 26. The fracture morphology of the lag ring was transgranular—typical of a fatigue-fracture mode.

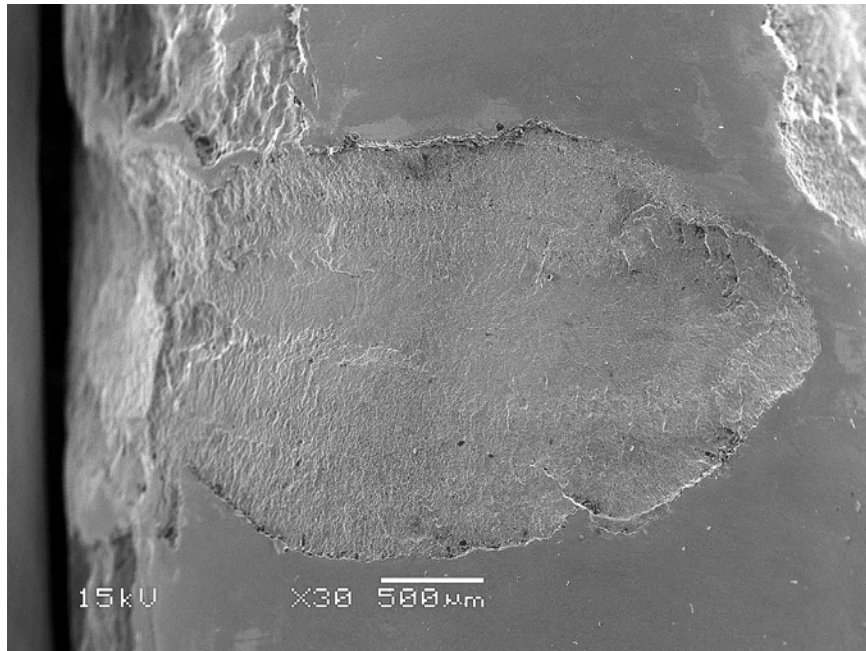
Figure 27. Surface spalling (fatigue pit) exhibited by a lag roller—typical of the spalling observed on the other lag rollers.

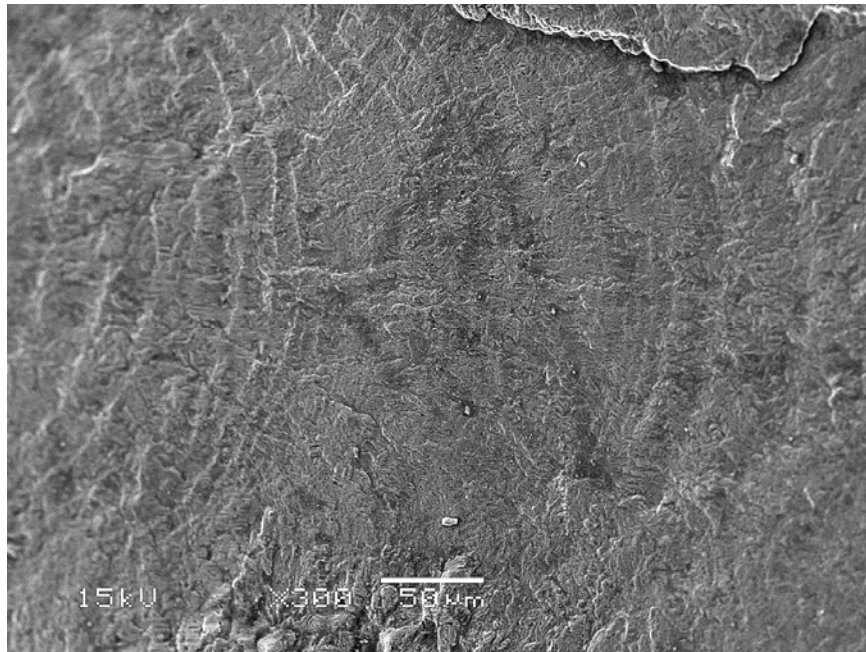
Figure 28. Detail of the spall depicted in figure 27 showing the beach marks typical of RCF-induced spalling.

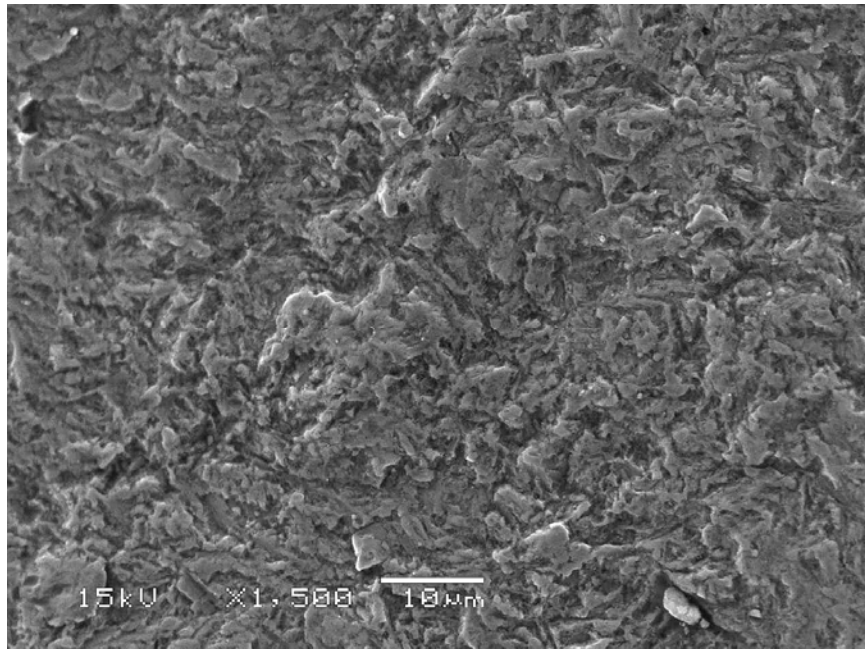
Figure 29. Detail of figure 28 showing the transgranular fracture morphology of the spalled surface typical of RCF-induced spalling.
