The Boeing Company
P.O. Box 16858
Philadelphia, PA 19142-0858

June 19, 2002
02-8-1130-0916

Subject: Chinook ZD576 Accident on the Mull of Kintyre – Evidence before the House of Lords Select Committee: Request for Boeing Review and Re-simulation.

Enclosure 1
02-8-1130-0916 (ASI Ref. 8-7D20-DSS-0306)

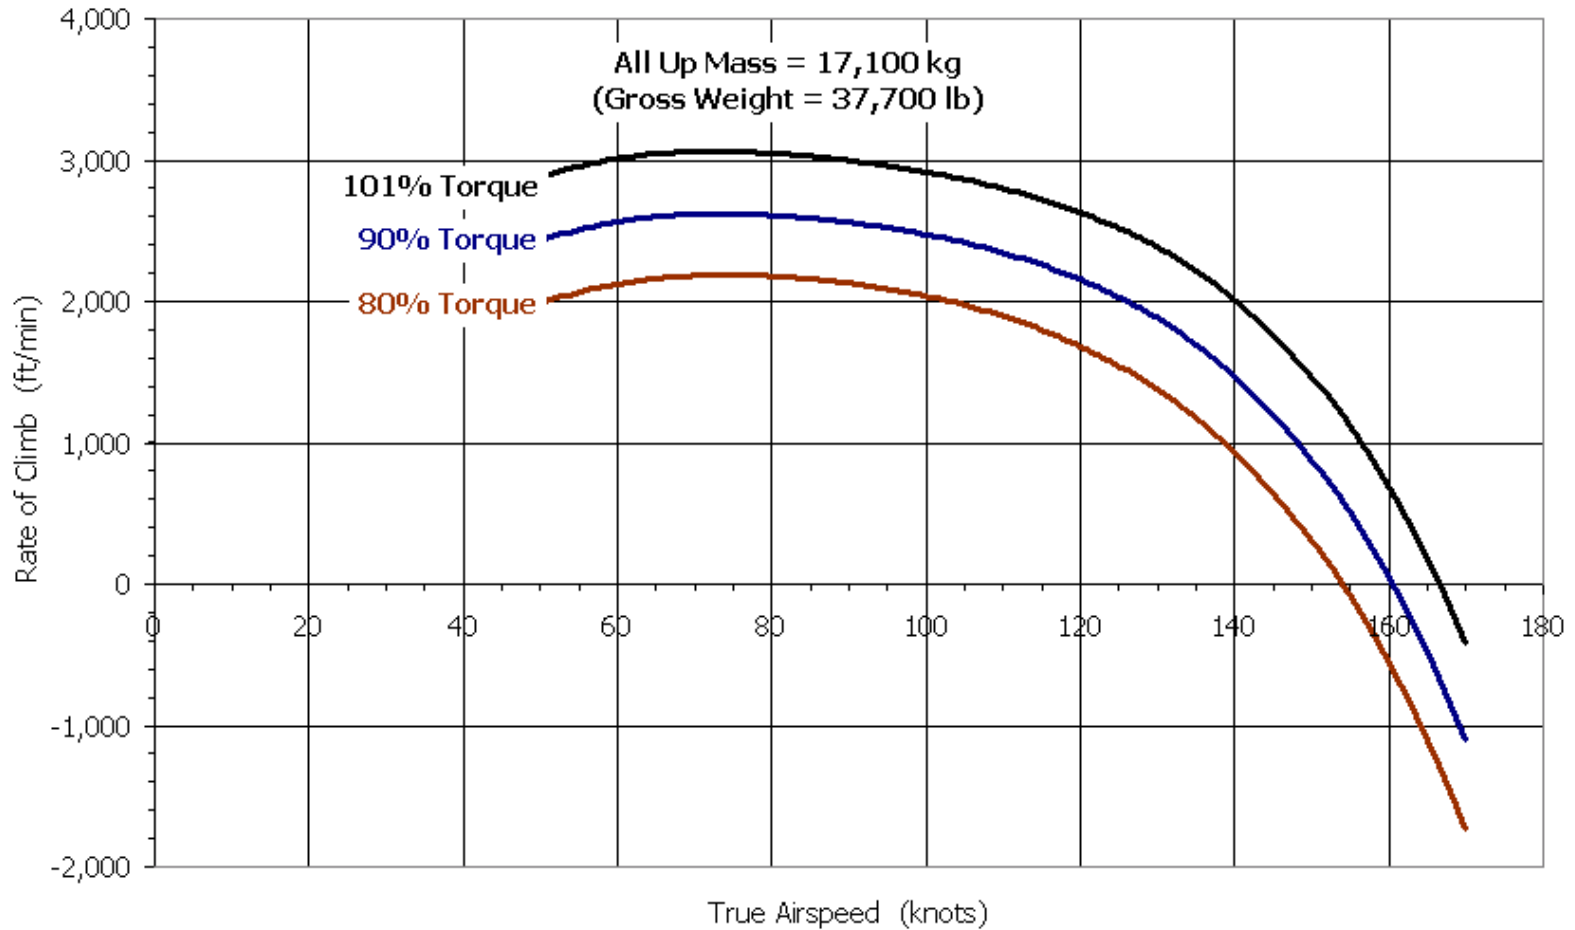
HC Mk2 Forward Climb Capability

The various references to rate of climb (ROC) vs. airspeed that the HC Mk2 supposedly cannot achieve are puzzling. Boeing Philadelphia's Aerodynamics Department, responsible for calculation and compilation of the performance data in the HC Mk2's Operators Manual have produced charts for ROC vs. Airspeed that show the following: For an HC Mk2 in the conditions that ZD576 was operating in at the time of the accident, ROC capability at 150 kts (TAS) should be approximately:

This data is based on an aircraft with minimum performance engines. The performance charts (Pages 7 & 8) from which this data was taken have been reviewed by several Boeing test pilots who found them to be accurate. While we don't have flight test data to present here to confirm this, we are fairly confident that this performance is achievable. Due to the sensitivity of the ROC/TAS relationship as the aircraft approaches limiting conditions, variation in pilot technique, difficulty in selecting and maintaining limiting torque and gauge errors, collection of this data can be difficult in less than optimally controlled conditions. While testimony may seem credible, there is no substitute for properly instrumented aircraft in a controlled flight testing environment.

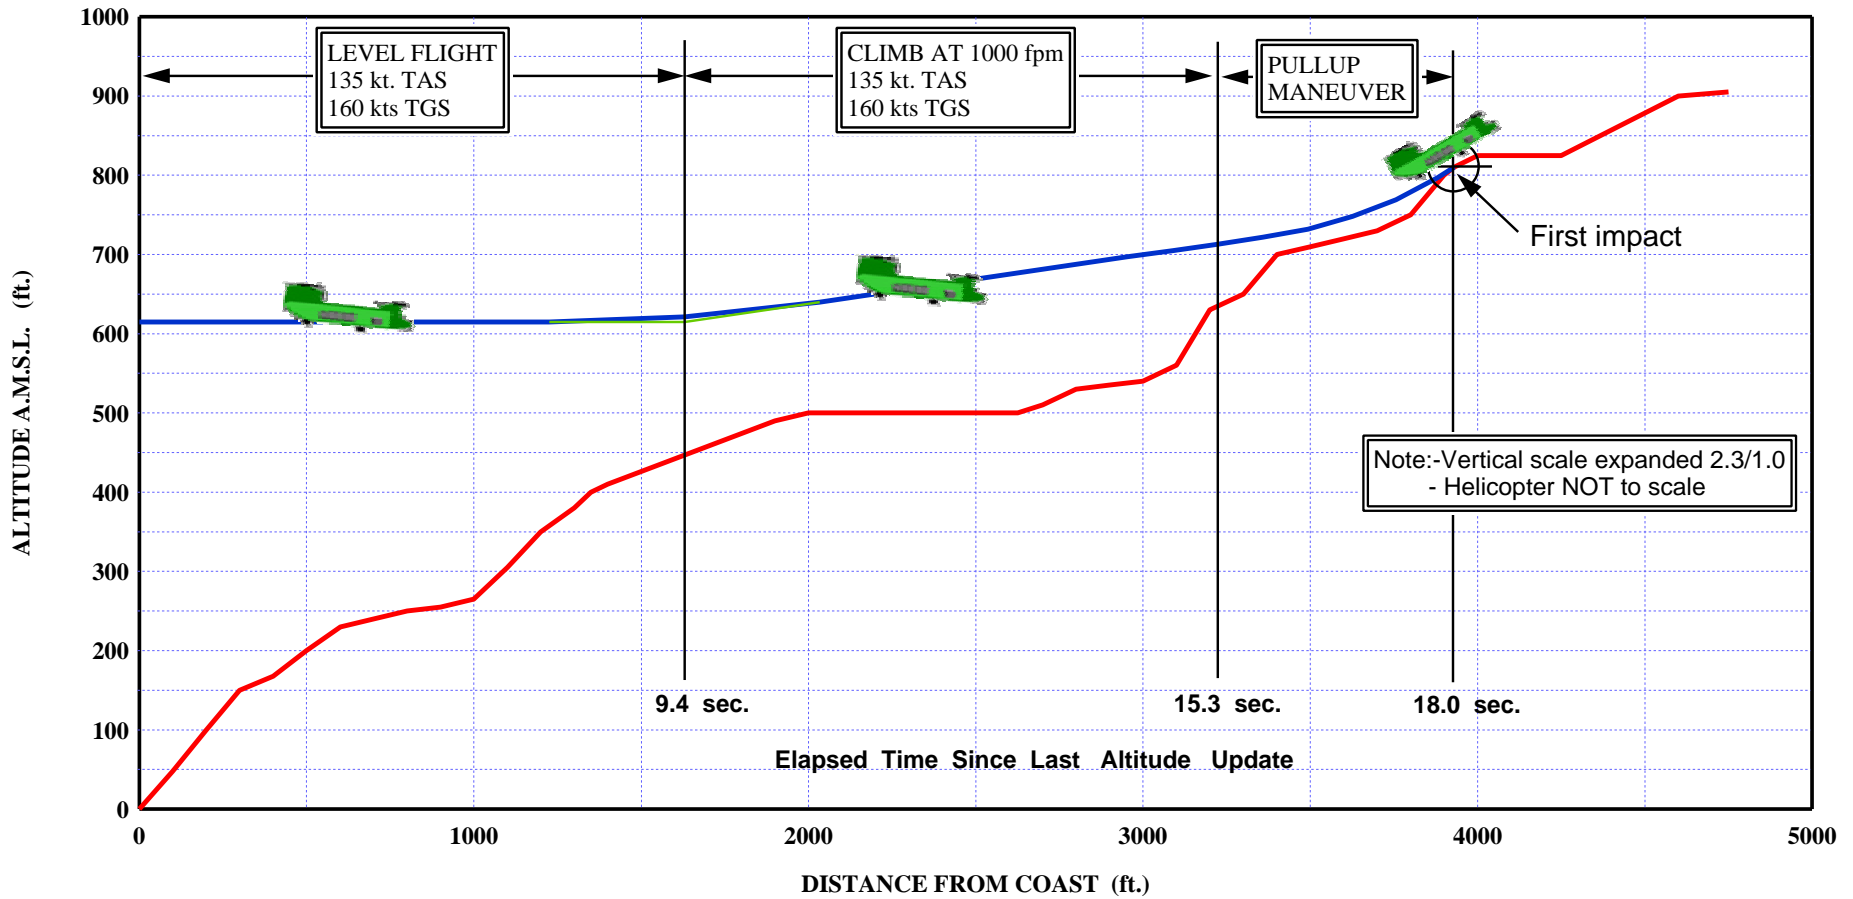
Figure 3
HC MK 2 ZD 576 MULL OF KINTYRE
FLIGHT PATH AND TERRAIN PROFILES (CASE A-24)

PULLUP MANEUVER
 Initial A/S 135 kts
 Initial R/C 1000 fpm
 Collective Input 0.5 in.
 Long. Input 2.0 in.
