Mull of Kintyre – Analysis of Available Data

Summary

Prepared by:

James Mitchell
Technical Fellow
The Boeing Company

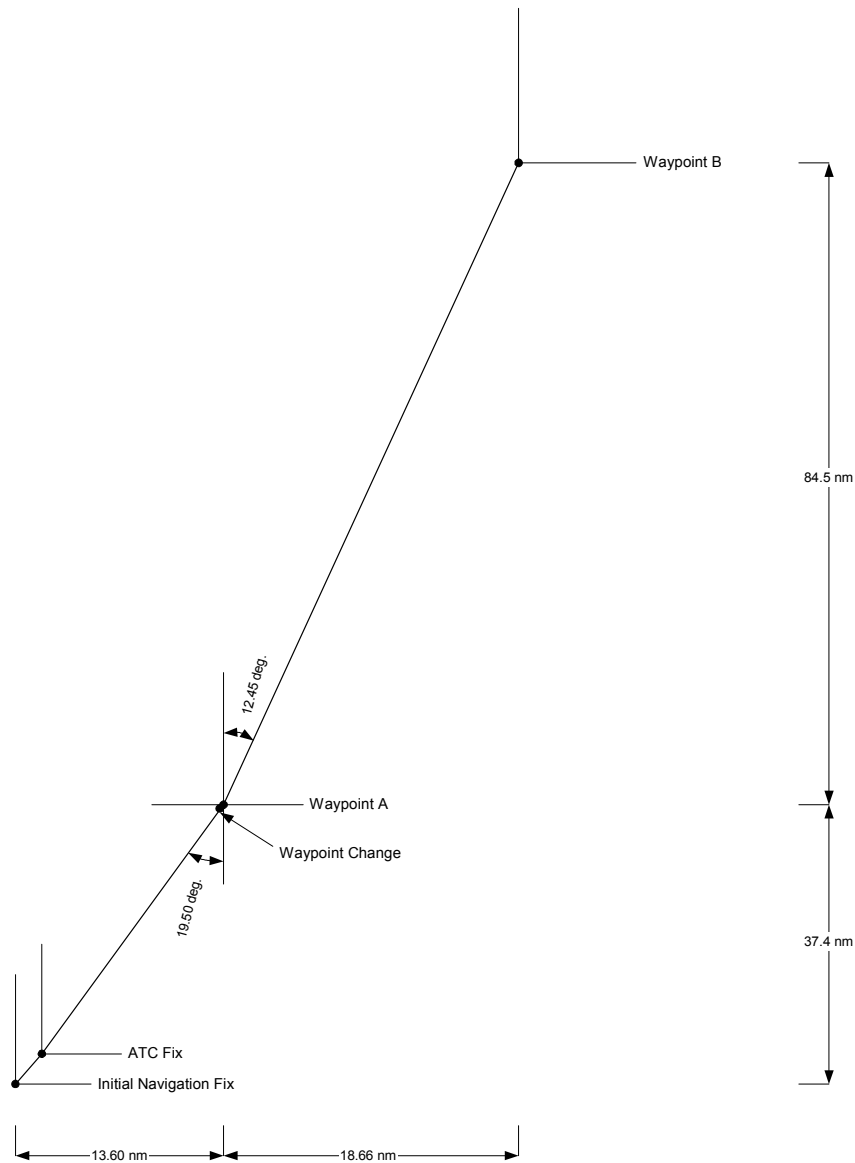
Figure 1. Overall Flight Plan Geometry

The overall horizontal navigation picture is shown in Figure 1. This identifies the basic planned route parameters from the initial navigation fix to Waypoints A and B. The following Table lists the latitude and longitude of the major points of interest.

From the overall aircraft flight path shown in Figure 1, it can be seen that the majority of the mission, from the ATC fix up until the accident, was conducted at a constant aircraft track of 20 degrees, i.e. the bearing from the initial fix to waypoint A. Using this track, and the surface wind speed (15kt average) and direction, the groundspeed values calculated above result in average true airspeed values of 147.6kt (minimum), 150.0kt (maximum), and 148.8kt (mean). It should be noted that this range of airspeeds is somewhat higher than the generally accepted operating parameters for the aircraft, where a cruise airspeed of approximately 135kts is normally used as being optimum for both aircraft range and pilot comfort.

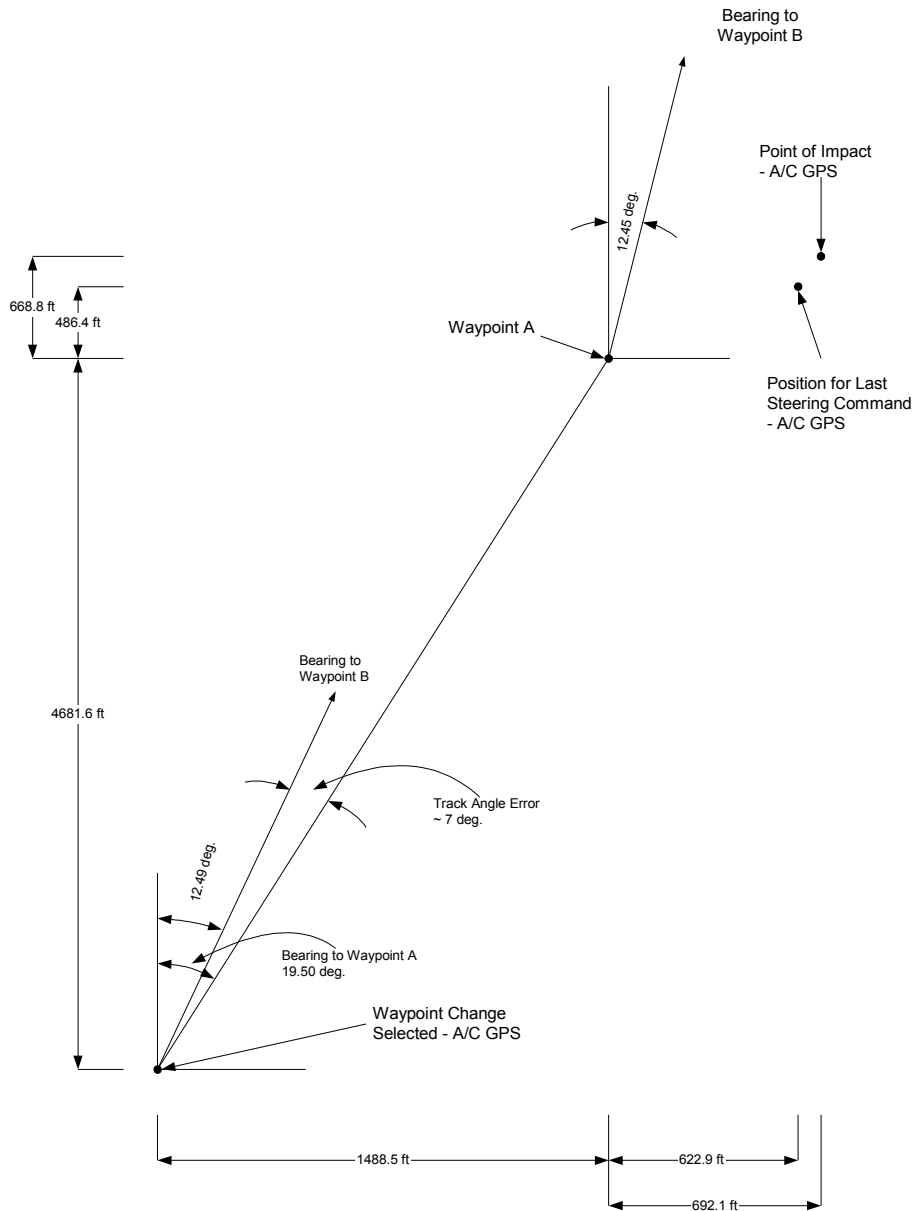
Figure 2. Flight Path Geometry Relative to Waypoint A

Figure 2 shows the relative geometry of the aircraft situation relative to Waypoint A. This sketch is approximately to scale, and it is clear from the position at impact that the aircraft had not made the turn to follow the directed course to Waypoint B. In fact, the aircraft was now not only right of the new course, it was also right of its original course from the ATC fix to Waypoint A.

The bearing from Waypoint Change to Last Steering Command is 22.22 degrees True, which indicates that the route of the aircraft is ~3 degrees right of the initial route and ~10 degrees right of the directed route from Waypoint A to Waypoint B

The bearing from Last Steering Command to Point of Impact is 20.77 degrees True, which indicates that, at the last moment, a left turn was initiated by the aircraft

This data would seem to indicate that the flight crew had made a conscious decision, for some reason, not to follow the directed route to Waypoint B. Some further discussion of the possible reasons behind this unexpected change of course is provided in Section 4.3.

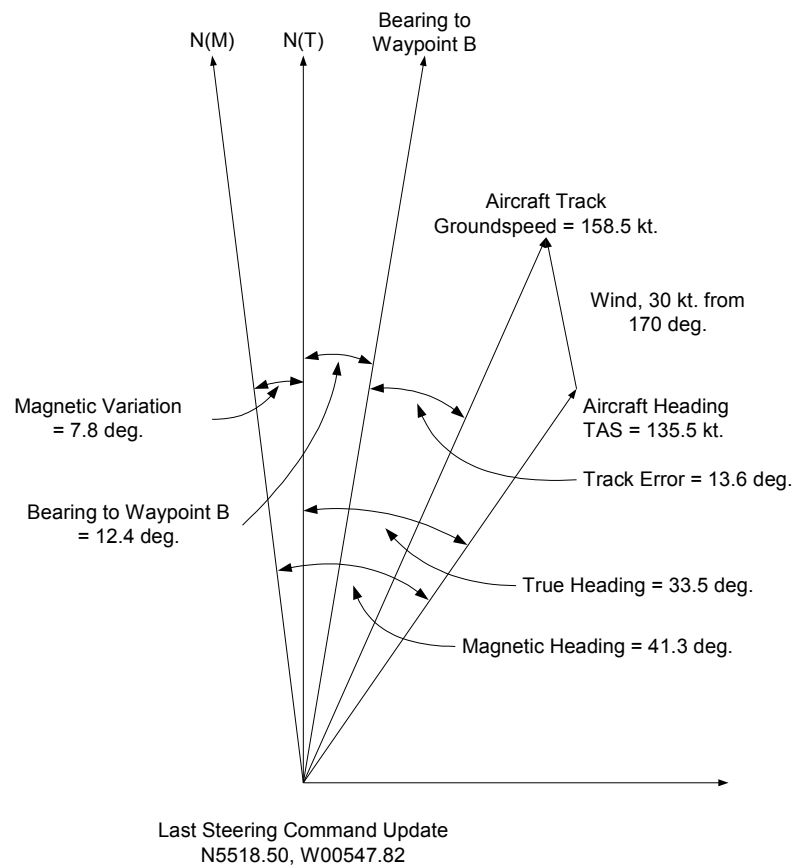
Figure 3. *Flight Path Geometry at Last Steering Command Calculation*

Figure 3 shows the aircraft flight path definition that can be calculated from the SuperTANS data logged at the last time the steering command calculations were updated. The steering command calculations are updated every second, which implies that this data was recorded less than a second before impact. Based on the differences in latitude

and longitude between the steering command calculations and the point of impact (aircraft power down), and using the last known aircraft ground speed, it is estimated that these last calculations were made ~0.75 seconds prior to impact. The data appears to make a consistent set, i.e. no inconsistencies were noted between the SuperTANS recorded data and hand calculations. It should be noted that at the time these calculations were made, the aircraft appears to have been close to a “wings level” flight condition. This observation is based on the last recorded value for aircraft turn rate, which was indicating +0.07 degrees per second, i.e. a very gradual turn to the right. This does not address the aircraft rate of climb or descent at the time, since this data is not recorded as part of the steering command calculations.

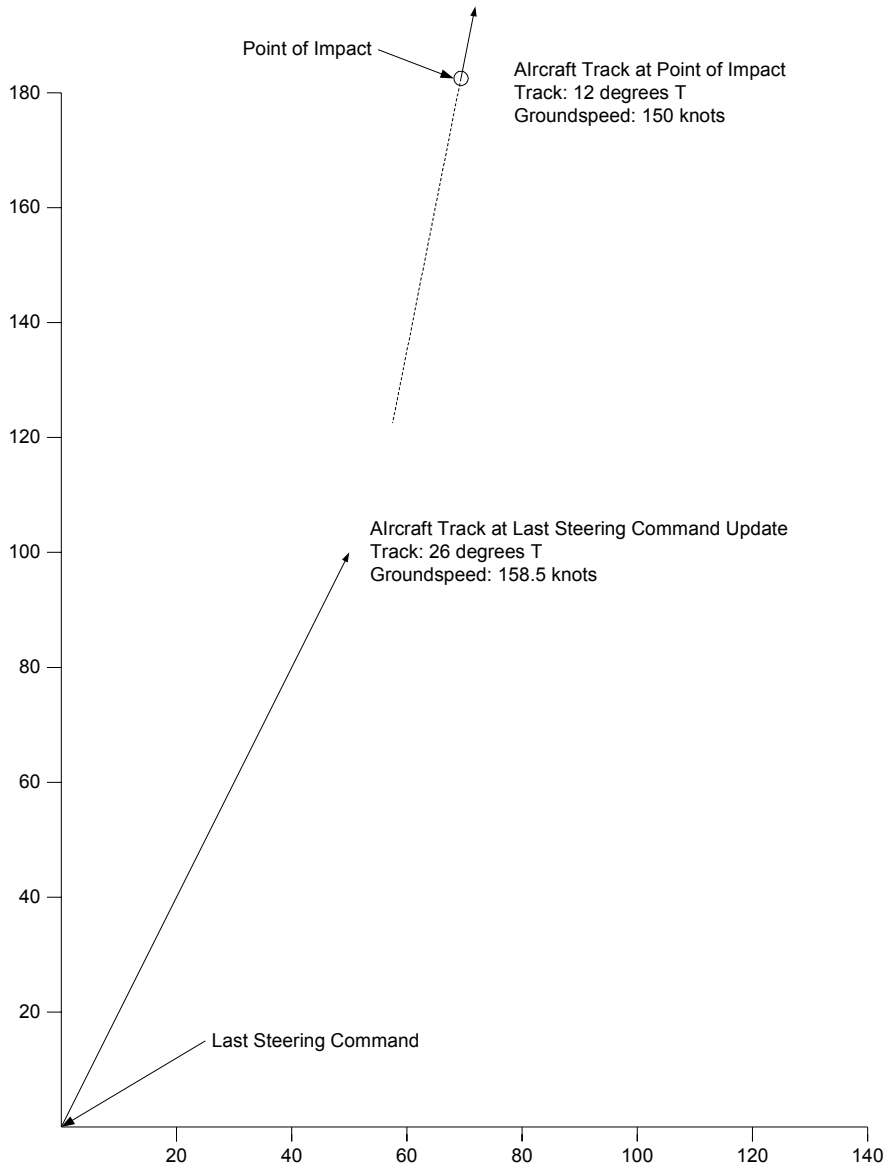
Figure 4. Point of Impact Geometry Relative to Last Steering Command

Figure 4 shows the aircraft flight path from the time the last steering command calculations were recorded until the point of impact, using the wheel track direction as the “preferred” source of information for the aircraft track at point of impact. The only data that is undeniably valid for the actual point of impact is the aircraft track based upon wheel track directions, which was documented by the AAIB. As noted in section 2.4, the recorded SuperTANS data related to the point of impact must be considered to be potentially misleading at some level. Since this data strictly refers to the conditions at equipment power down, and since it is not known how long power was available to specific pieces of equipment following impact, it must be considered to have been possibly compromised to a lesser or greater extent by the process of the aircraft breakup. For example, detachment of the pitot-static tubing during the aircraft breakup can corrupt the last recorded airspeed measurements. However, other data can be assumed to be still valid, i.e., because of the limited time span, the wind speed and direction can be assumed to be unchanged from the values used for the last steering command calculations.

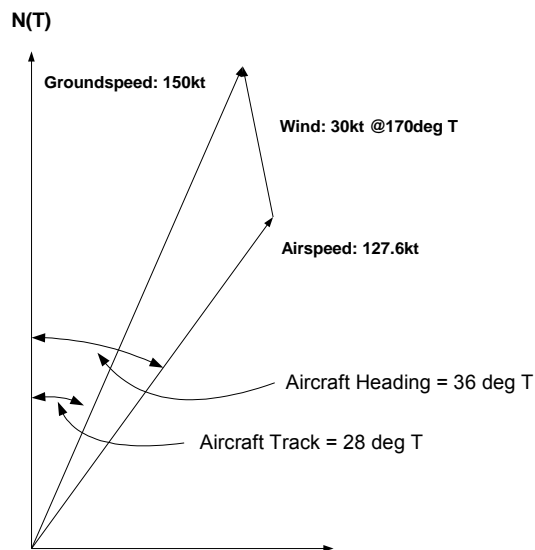
Figure 5(a). Flight Path Geometry at Impact Using Recorded Velocity Data

To initiate the analysis, Figure 5(a) was constructed solely from a “triangle of velocities” as one method of determining the aircraft flight conditions at the point of impact. This shows what the aircraft track and heading would have been if the airspeed and groundspeed parameters recorded as being “at impact” were assumed to be both correct and consistent. Using the same wind speed vector as for the steering commands, the aircraft track is calculated at 28 degrees True. This has to be incorrect for two reasons: firstly it places the track of the aircraft to the right of the known bearing from the last steering command calculation to the point of impact; and secondly it does not agree with the physical evidence of the tire tracks.

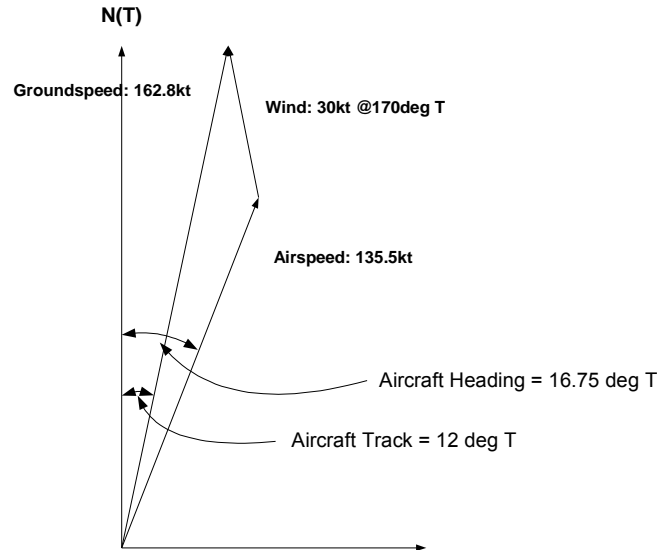
Figure 5(b). *Flight Path Geometry at Impact Using Tire Tracks and Constant Airspeed*

If, however, some different assumptions are made, a picture that is more consistent with the other available data becomes apparent. This is shown in Figure 5(b), where the

assumption is that the aircraft airspeed remained relatively constant over the period from the last steering command being calculated and the point of impact. Given that the time difference between these two events is only ~ 0.75 seconds, and that the apparent change in airspeed would have required a deceleration over this period of $\sim 0.6g$'s, this assumption seems valid. Using this airspeed, the evidence of the tire tracks, and the wind speed, an aircraft groundspeed just prior to impact of 162.8kt is arrived at, with an aircraft heading of 17 degrees T or 24.8 degrees M.

This calculated groundspeed value is consistent with the value of groundspeed derived from the last displayed values of distance to go and time to go values that were recovered from the steering display. These values were 86.7nm and 32min, respectively, which results in a groundspeed of 162.6kt, i.e. very similar to the calculated value of 162.8kt, particularly when the potential errors inherent in the resolution of the displayed data are factored in.

The effects of the data sampling, latency, and filtering described above could also explain the apparent inconsistencies between Figure 5(a) and 5(b), particularly if the filtering, etc, applied to the groundspeed measurements was different than that applied to the airspeed.

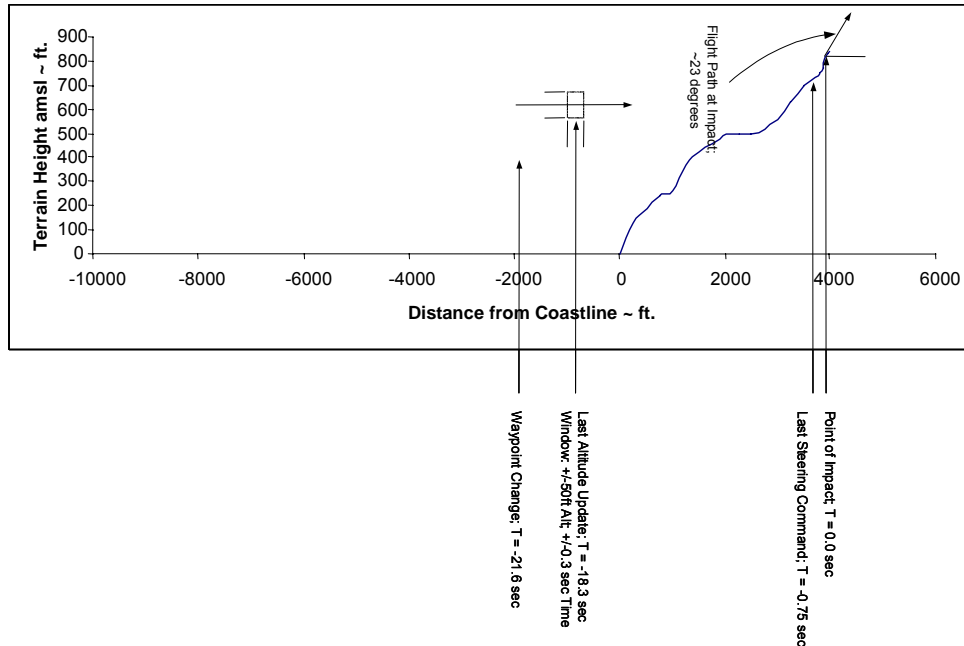
Figure 6. Vertical Flight Path Relative to Last Altitude Update

Figure 6 shows the two pieces of data that locate the aircraft vertical flight path from the point of last altitude measurement until the point of impact. Note that the actual measured altitude at that point was not recorded, but was derived from other related parameters that were recorded. Altitudes are shown as height above sea level. Both altitudes have been corrected to height above sea level using a correction factor of 145ft that was calculated as the difference between the surveyed altitude of the crash site and the data recorded at the time of impact, i.e. $810 \text{ (ft amsl)} - 665 \text{ (ft baro)} = 145 \text{ ft}$ correction. This places the nominal altitude at the last measurement at 613ft amsl (= 468ft + 145ft). Also shown is the estimated aircraft flight path angle at the time of impact. The terrain profile was copied from the profile provided in paragraph 5.5 of the AAIB Report.

The location in space of the altitude measurement position was determined as a window, based upon the time counts and the accuracy of the altitude derivation. As documented in section 2.7.b, the time count stood at 30 at the time of impact, which places the time window between 30 and 31 counts, with each count being equivalent to ~ 0.6 seconds. The time counts were converted into distance using a groundspeed of 158.5kt, which is consistent with both the “average” course speed and the known speed at the last steering command calculation. The near edge of the window is set at 30 counts * 0.6 seconds per count, and the far edge is set at 31 counts * 0.6 seconds per count.

Other points shown are the aircraft position for the last steering command calculations and the position of the waypoint change selection. These latter two positions are located based upon their distances from the point of impact, which are known values. The time deltas associated with these positions were also determined using a groundspeed of 158.5kt.

The altitude of the aircraft at the last steering command position can be quickly determined to be within a range from ~ 740 ft (the height of the ground) to 810ft (the height at the point of impact). It should be noted that tracing the 23 degree flight path angle from the point of impact back to the position of the last steering command places it at an altitude of ~ 730 ft amsl, which is below the height of the ground at that position. This also lends credence to the conclusion that the final 23 degree flight path angle was achieved only in response to some last second control inputs.

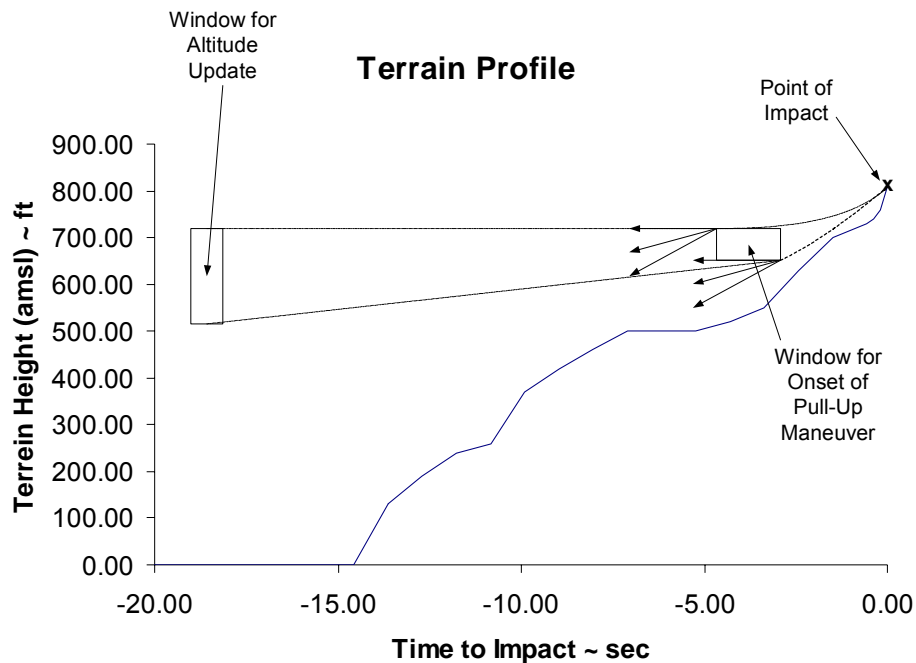
Figure 7. Vertical Flight Path

The first window boxes the possible range of aircraft altitudes at the last altitude update point. This window height is shown as being relative to the final impact point, i.e. the lower edge of the window is 296ft below the final impact point and the upper edge is 98ft below the impact point, using the measurement resolution analysis shown above. This is in comparison to the equivalent window from Figure 6, which showed the altitude accuracy only in terms of sensor measurement accuracy, i.e. +/-50ft. As before, the window width is shown as 0.6 seconds, with the window nominally placed at 18 seconds prior to impact.

The second window boxes the range of entry points for the final pull-up maneuver, based on the results of the simulation as described above. The lower edge of the window is 150ft below the final impact point, and the upper edge is 100ft below. The width of the window extends from 3.5 to 5 seconds from impact. There are fan indications at two of the corners of this window. These indicate the angles associated with the entry flight path into the window being at 0, 1000, and 2000 feet per minute, respectively. For further illustration of the final pull-up maneuver, the corners of this window are connected with curved flight paths to the final impact point.

The terrain features effectively preclude the aircraft from entering the window at the lower edge with a sustained climb rate of 2000fpm. However, it is possible that the aircraft was maintaining an essentially level flight path until approximately 7 seconds before impact, at which point the flight crew would have received an altitude warning from the radar altimeter, which was reportedly set at 69ft for one of the two instruments. The flight crew would be expected to then initiate a climb maneuver, which could place the aircraft at the lower edge of the window with a climb rate of 2000fpm or more. However, this explanation must also be tempered with the knowledge that the engines were not at maximum power at impact, whereas the flight crew would be expected to have commanded maximum engine power in conjunction with this initial climb command. This reasoning also does not explain why the flight crew would have been maintaining a level flight path with the knowledge that they were approaching rising terrain.

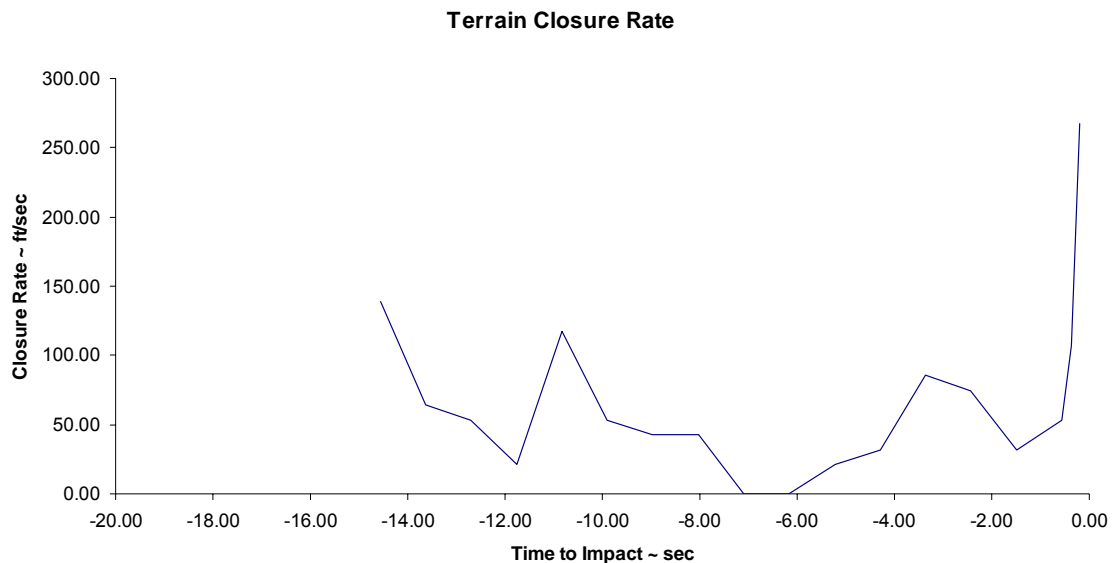
Figure 8. Terrain Closure Rate

Figure 8 shows the terrain closure rate that would be generated from the terrain profile shown in Figure 7. This closure rate is for an aircraft maintaining level flight with respect to the terrain, and again is shown versus time to impact. The effective closure

rate is reduced by the aircraft climb rate: a climb rate of 500ft/min would reduce the closure rate by 8.33ft/sec and a climb rate of 1000ft/min would reduce the closure rate by 16.67ft/sec. Applying these factors to Figure 8, it can be seen that, although there are potentially some transient conditions where the net closure rate exceeds 100ft/sec, in the main the net value is less than this. Thus, the anomaly in radar altimeter performance detected by the AAIB should not have prevented a low altitude warning from being generated.

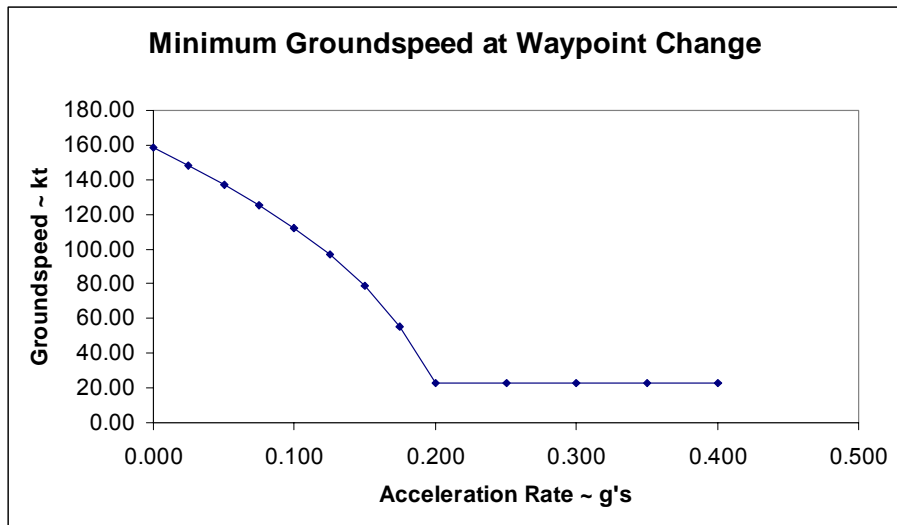
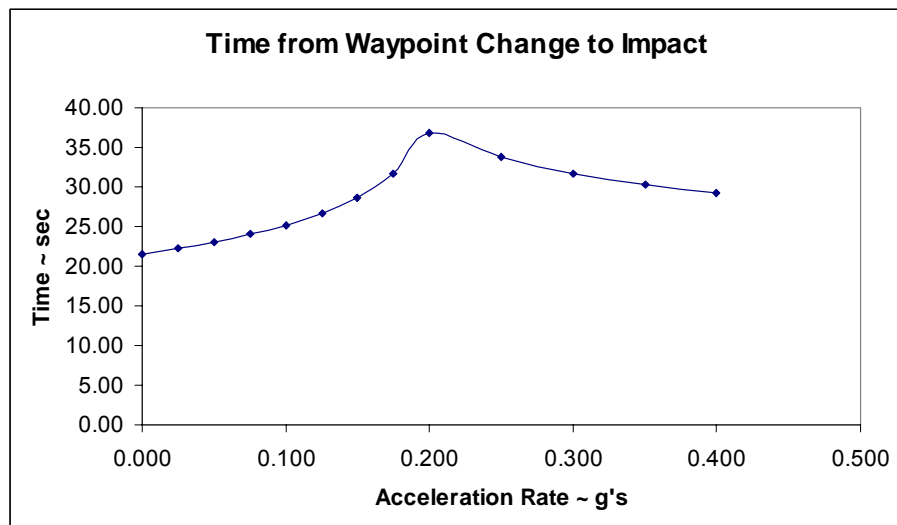
The following figures illustrate the effects of the aircraft acceleration from a minimum speed at the waypoint change to the final speed just prior to impact. These calculations describe the results from equation (5), and also reflect that the minimum groundspeed at the waypoint change of 23kt, based upon the wind speed contribution.

Note that the maximum time from the waypoint change to impact coincides with the minimum acceleration for which the minimum groundspeed at the waypoint change corresponds to the aircraft being at zero airspeed. The minimum time coincides with the aircraft traveling at constant speed from the waypoint change to impact.

In reviewing the data, it can be clearly seen that the number of conditions that satisfy all constraints shrinks dramatically as the acceleration rate reduces. This is because, as seen in Figure A1, the aircraft cannot attain the final groundspeed at impact with a low acceleration rate unless there is an appreciable groundspeed at the waypoint change.

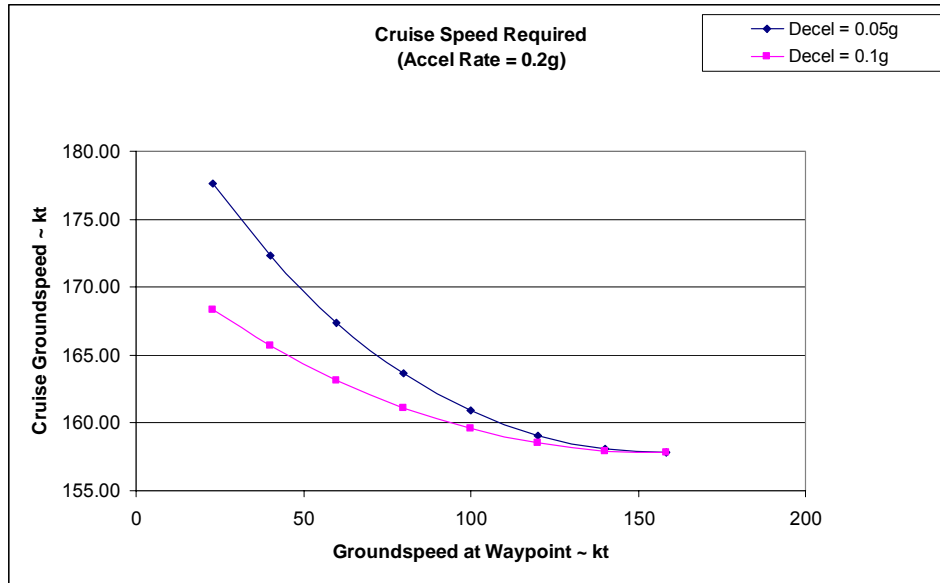
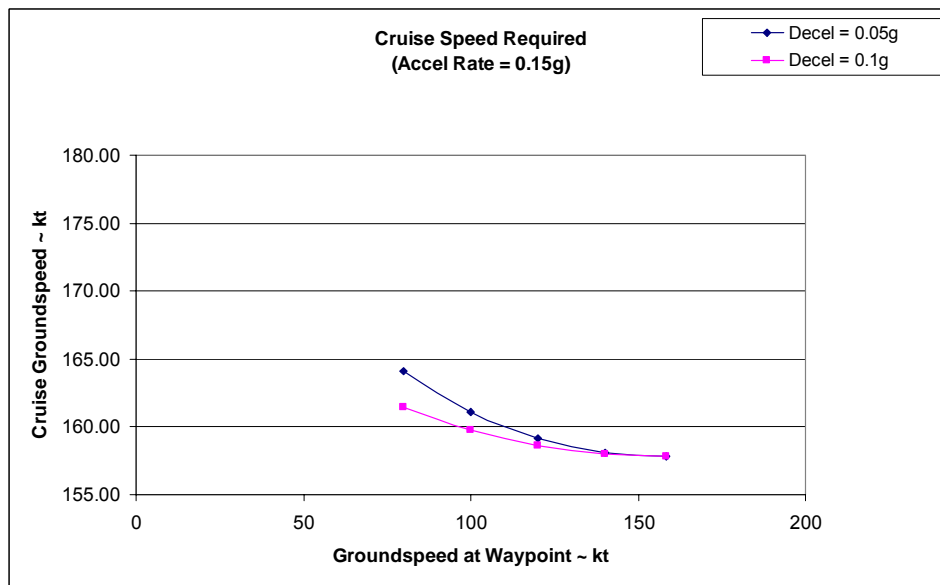
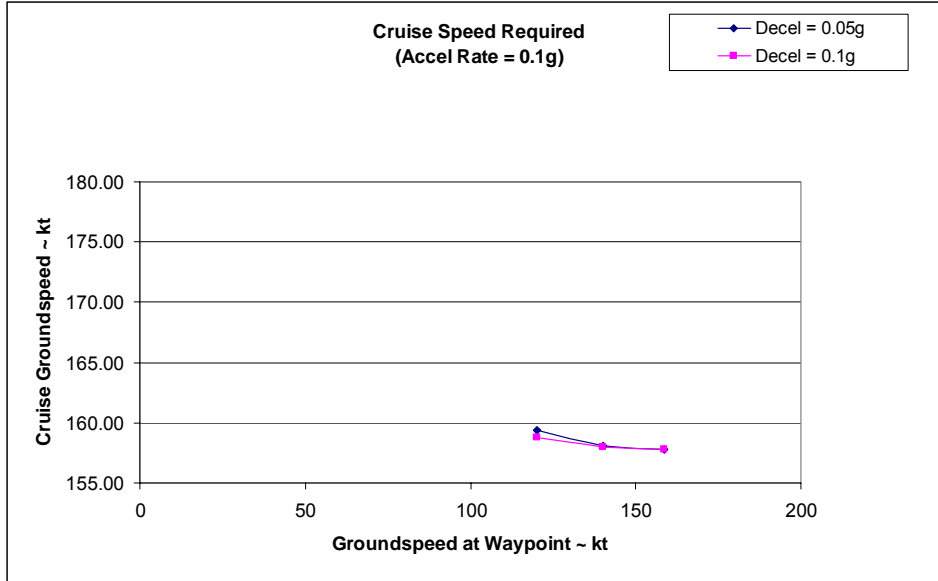
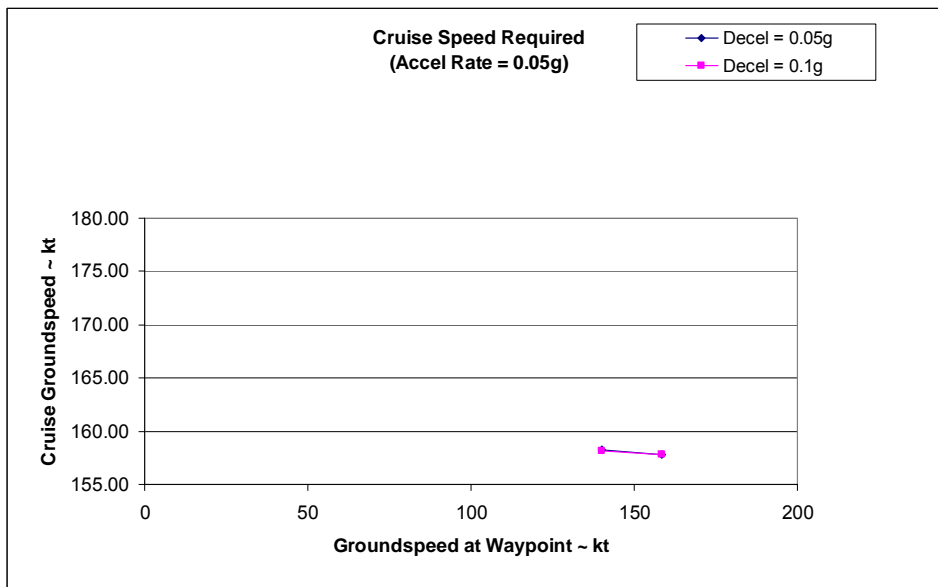
The following figures illustrate the cruise groundspeed required versus speed at the waypoint change for a variety of aircraft acceleration and deceleration rates. Again, the minimum groundspeed at the waypoint change is shown as 23kt, which is the wind speed component assuming a wind of 30kt at 170degrees.

It can be seen that the curve of cruise groundspeed versus the groundspeed at the waypoint change is not significantly affected by acceleration rate. This is because, as seen in Figure A2, the variations in time required to cover the distance from the waypoint change to the impact point are not sufficient, in a relative sense, to affect the cruise speed calculations. Specifically, the variation is approximately 15 seconds between minimum and maximum times. Relative to the total ATC fix to impact flight time of ~800 seconds, this variation is equal to less than 2 percent of the total.

Similarly, if these cruise groundspeed values are reduced by ~ 9kt to account for the wind speed contribution over the cruise portion of the flight, it can also be seen that many of the high acceleration rate conditions will fail the maximum airspeed limit, i.e. airspeed values of ~155kt and greater are in excess of the aircraft level flight speed limits.
