Metallurgical Examination of a Failed  
Blade Lag Shock Absorber  
(Part No. 114H6802) From a CH-47D  
Chinook Cargo Helicopter

ARL-TR-2191

March 2000

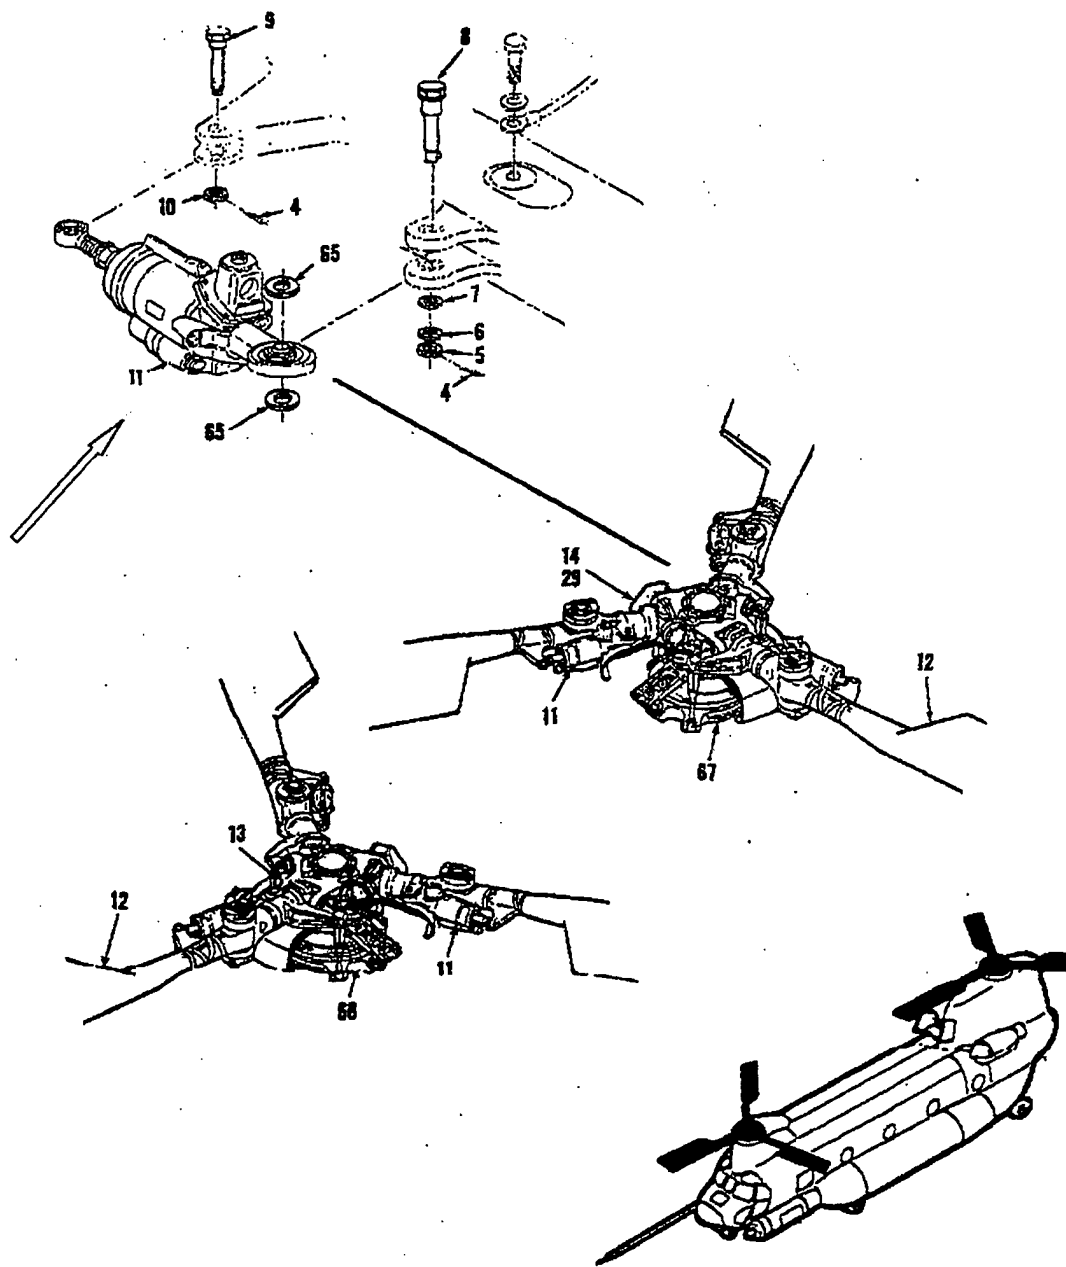
**Figure 3. Schematic Showing the Location of the Blade Lag Shock Absorber on the CH-47D Chinook Helicopter.**

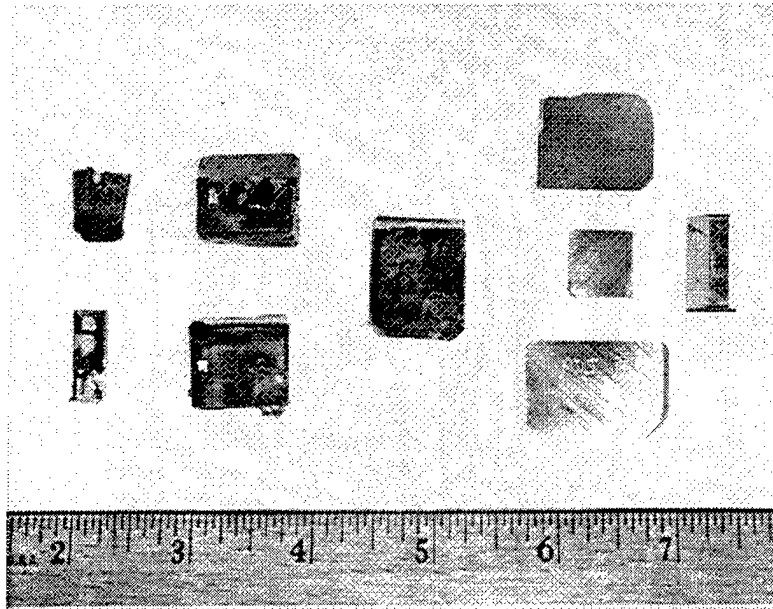
**Figure 4. Sections of the Failed Blade Lag Shock Absorber as Received From Boeing; Reduced 31%.**

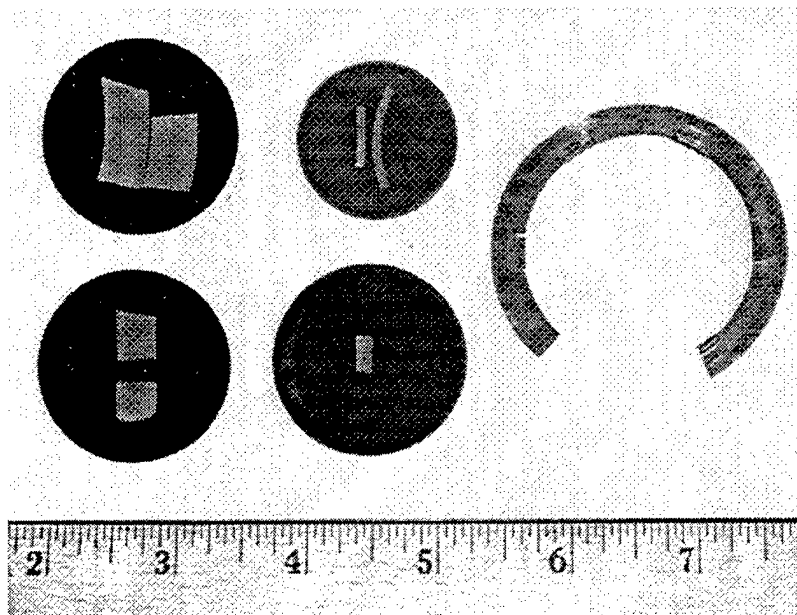
**Figure 5. Mounted Samples of the Failed Blade Lag Shock Absorber and a Sectioned Collar as Received From Boeing; Reduced 28%.**

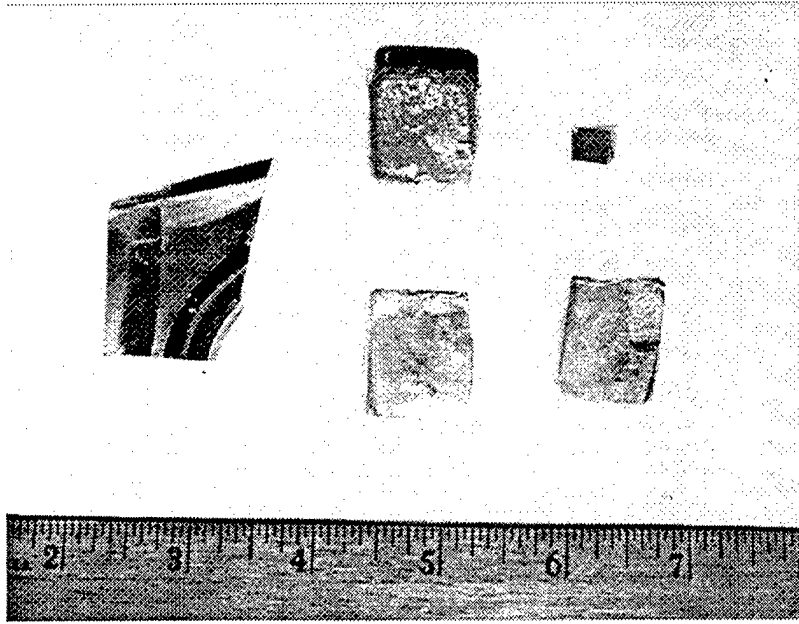
**Figure 6. Sections of the Failed Blade Lag Shock Absorber Including Fracture Surfaces as Received From Boeing; Reduced 31%.**

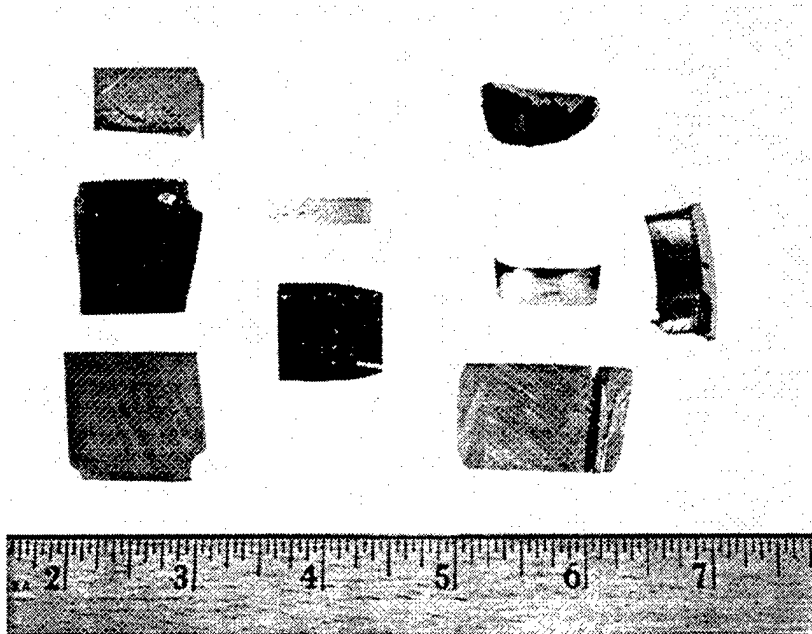
**Figure 7. Additional Sections of the Failed Blade Lag Shock Absorber as Received From Boeing; Reduced 31%.**

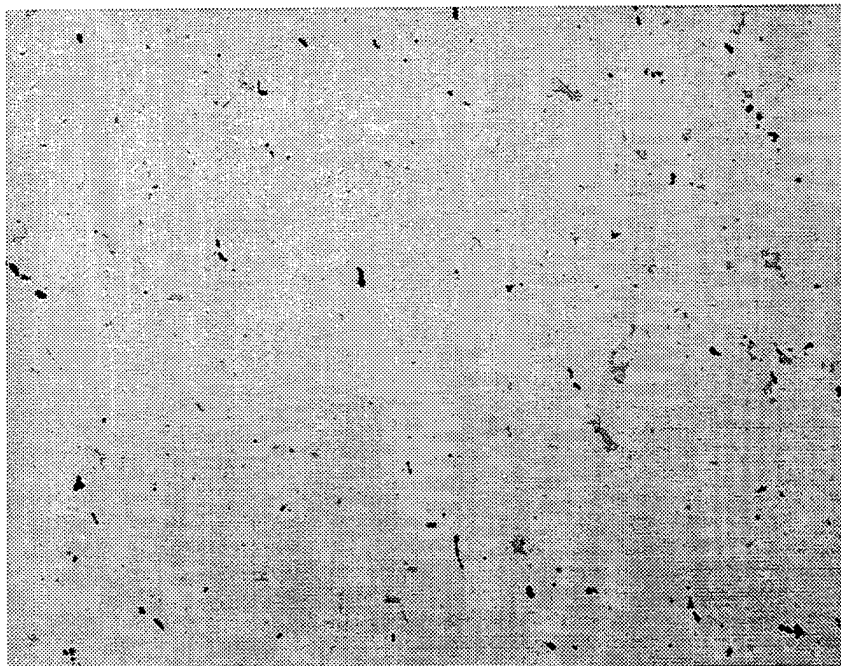
**Figure 15. Micrograph of the As-Polished Microstructure of the 7075 Alloy; Magnification 200 $\times$ .**

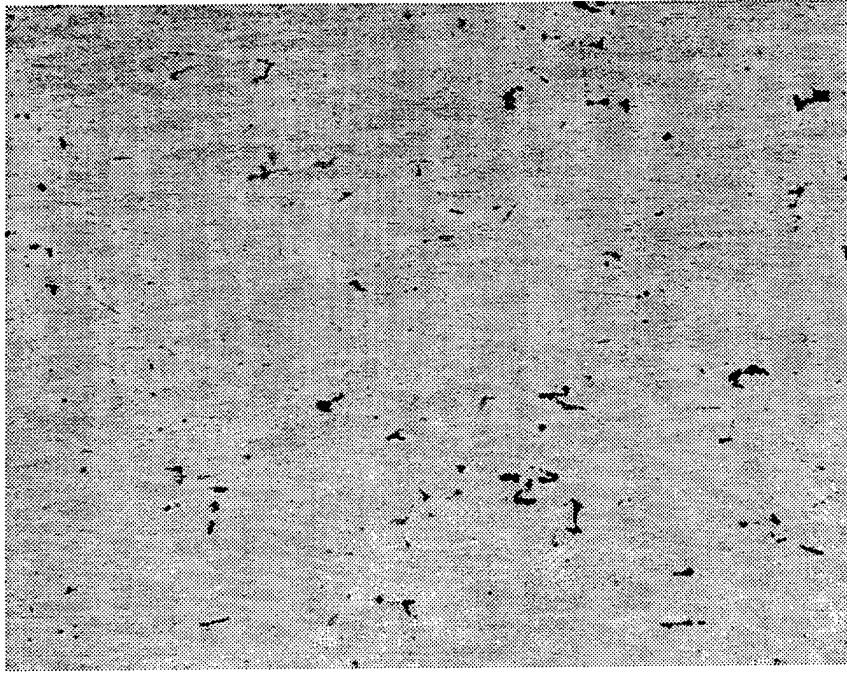
Boeing fabricated three transverse metallographic samples from the inboard lug. Evidence of intergranular attack was prevalent on each sample, extending along the bore wall and spot face of the lug. Figures 12 and 13 show examples of this corrosive attack in the as-polished condition, while Figure 14 shows another region of attack that had been etched with Keller's reagent. These areas of attack were located adjacent to the primary fracture. The average depth of the intergranular attack was approximately 0.010 in. The microstructure was examined in an effort to confirm that the part was properly aged to the -T73 condition. The major microstructural difference resulting from variations in time and temperature of -T73 tempers is the size and type of precipitate. However, these differences are subtle, and impossible to detect metallographically [6]. Moreover, transmission electron microscopy (TEM) is not adequate in distinguishing between these features. It is suggested within Davis [6] that the differences within a given temper (and between tempers) be established through hardness, conductivity and, in some cases, tensile yield results. The -T73 temper contains a mixture of  $\eta'$  and the stable, incoherent  $\eta$  ( $\text{MgZn}_2$ ) phase [7]. Figure 15 shows the precipitates of a sample sectioned through the chamfer in the as-polished condition. The light-gray particles were actually copper in color and represented the copper in the alloy. Figure 16 shows this structure etched with Keller's reagent at 200 $\times$  magnification. Note the directionality of the grains, indicative of the prior forming operation. Figure 17 shows this structure at higher magnification.

**Figure 16. Micrograph of the Etched Microstructure of the 7075 Alloy; Keller's Etch, Magnification 200 $\times$ .**

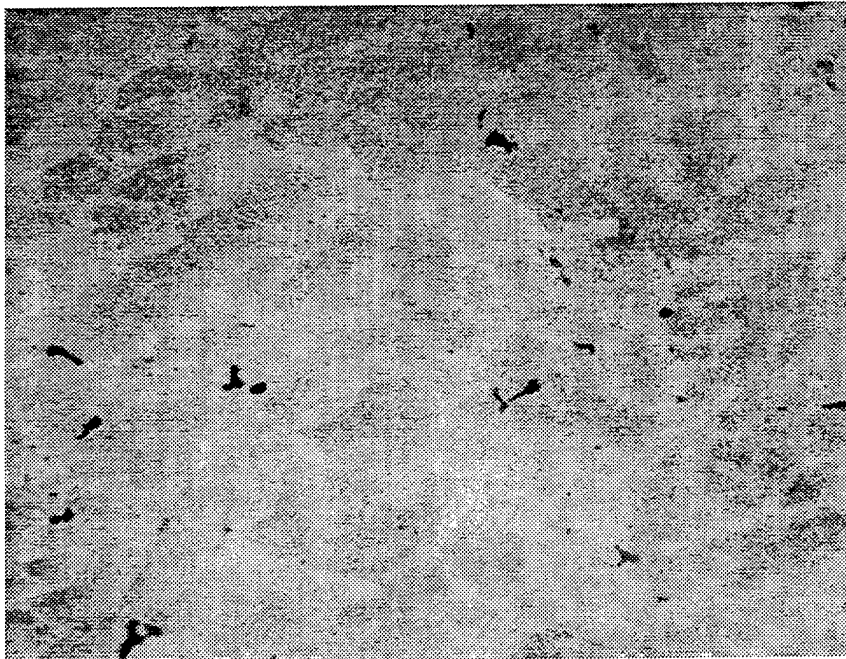
**Figure 17. Micrograph of the Microstructure Shown in Figure 16, at Higher Magnification; Keller's Etch, Magnification 500 $\times$ .**

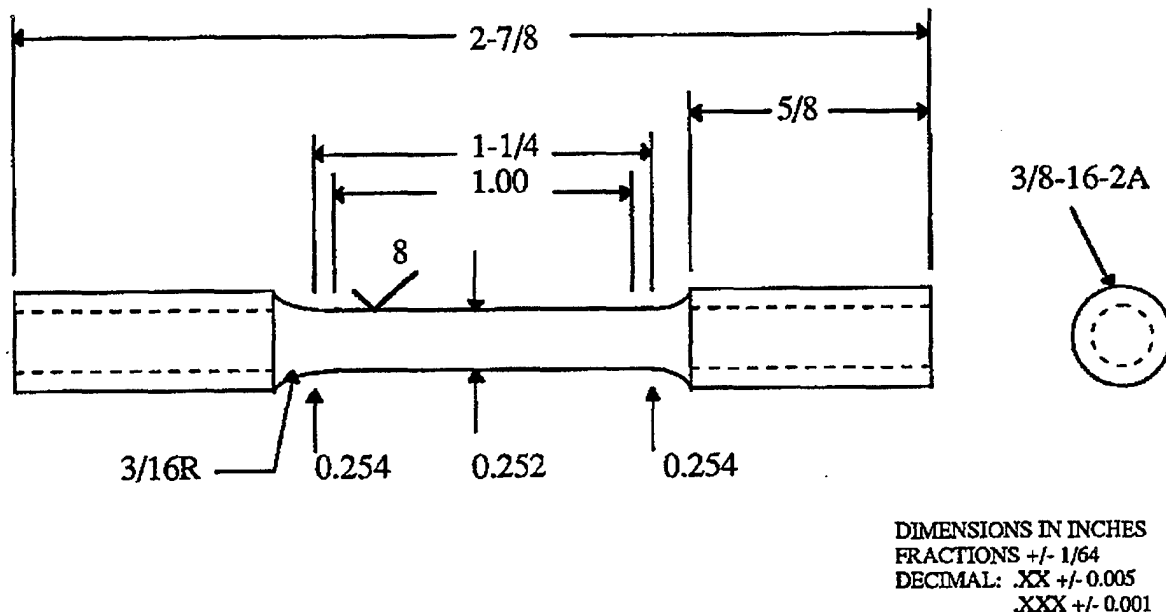
A total of five threaded specimens (Figure 24) was fabricated in accordance with the requirements of ASTM E8, "Tension Testing of Metallic Materials" [4]. It was the initial intent of ARL to fabricate subsize specimens from the failed "C" section of the lag damper itself adjacent to the fracture surfaces, but size constraints would have made the measurement of yield strength from these specimens impossible. Since yield strength was the primary mechanical property that ARL was to use as the acceptance criteria for this material, standard specimens were fabricated from the housing, adjacent to the location in which Boeing sectioned their three tensile specimens.

**Figure 24. Schematic Showing Dimensions of Tensile Specimens Sectioned From the Blade Lag Shock Absorber Housing and Tested by ARL; Specimen Conformed to ASTM E8 [4].**

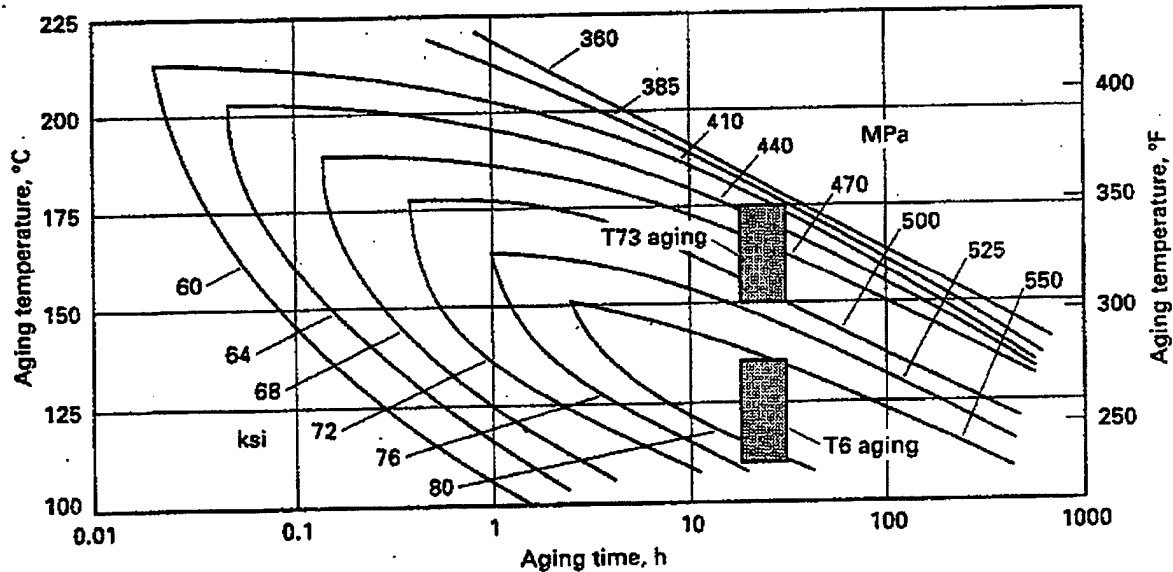
Figure 25. Iso-Yield Strength Curves for Aluminum Alloy 7075 [11].

Type 7075 aluminum in the -T73 condition offers a superior combination of high strength and resistance to stress corrosion and exfoliation corrosion. The strength is less than that of the -T6 temper, but the corrosion resistance is greater (as strength increases, corrosion resistance tends to decrease for this alloy). However, the properties obtained by this condition are extremely sensitive to small variations in aging times and aging temperatures (approximately five times greater sensitivity than that of the -T6 condition, for comparison). Consequently, control of both temperature and time to achieve the mechanical properties and corrosion resistance specified for these tempers is more critical than the control required in producing the -T6 temper [5]. The -T6 aging temperature can range from ~225° F to ~275° F with a variation in UTS of only 4 ksi. However, it has been shown that variations of 50° F during the -T73 aging treatment affects the UTS of -T73 by as much as 16 ksi. (Figure 25 [11]). In addition, the rate of heating from the first to the second aging step has to be taken into account since precipitation also occurs during this period. In order to determine whether the alloy had been properly aged, hardness and conductivity testing was performed. The material exhibited hardness and conductivity measurements within the respective limits but at the low end of the conductivity range and the high end of the hardness range. Tensile testing was conducted as the deciding factor to determine whether the proper aging sequence was performed, since the conductivity measured between 38.0 and 39.0% IACS (per MIL-A-22771 [3]). Testing tensile performed by ARL revealed yield strengths greater than the maximum requirement for four of the five specimens. Taking into account the tensile testing performed by Boeing, a total of five of eight specimens failed to meet this requirement. This showed that the material may not have been properly aged per the requirements of MIL-A-22771 [3]. It is possible that this would have facilitated intergranular attack, but it is also possible that the rework solutions may have had the same effect on properly aged 7075-T73 material.

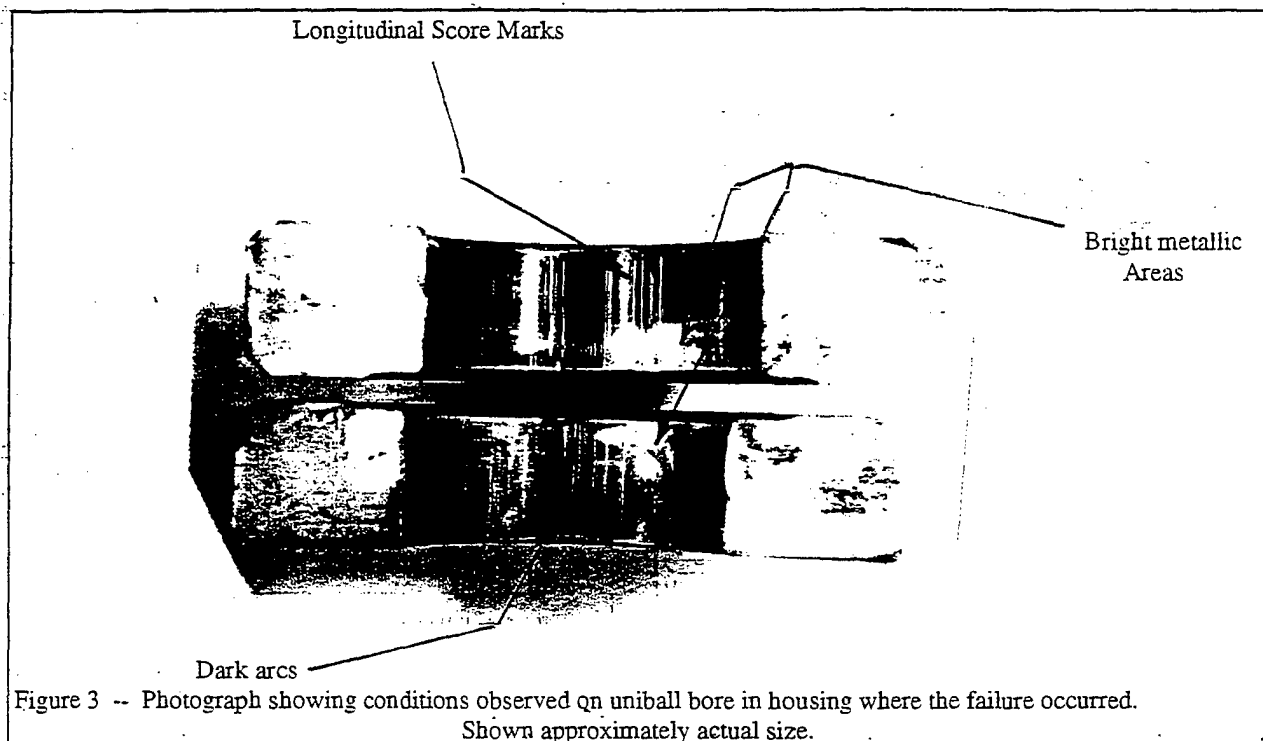
A single light tap with 8 oz. ball peen hammer was used to remove the portion of housing which remained attached to the bushing/uniball bearing. Inspection, at magnifications to 30X, of both halves of the unbearing bore in the housing revealed the following and are shown in Figure 3.

- \*\*\* The surfaces were covered with an oily residue.
- \*\*\* Longitudinal score markings, apparently resulting during installation, on the bore surface .
- \*\*\* Bright metallic areas to opposite sides of the width of bore surface. These areas were not completely around the circumference of the bore but were located to both sides of the primary fracture surface and appeared to have resulted due to applied pressure (as could occur due to high areas as the bushing was installed).
- \*\*\* Arc shaped darker colored areas were noticeable on both sides of the bearing width, located 90° to the fractures, and on the portion of the bore which stayed on the remainder of the housing.
- \*\*\* There appeared to be slight pitting corrosion on the bore surface and on the side of the housing located under the busing.

\*\*\* Areas other than those described above were mostly black in color.

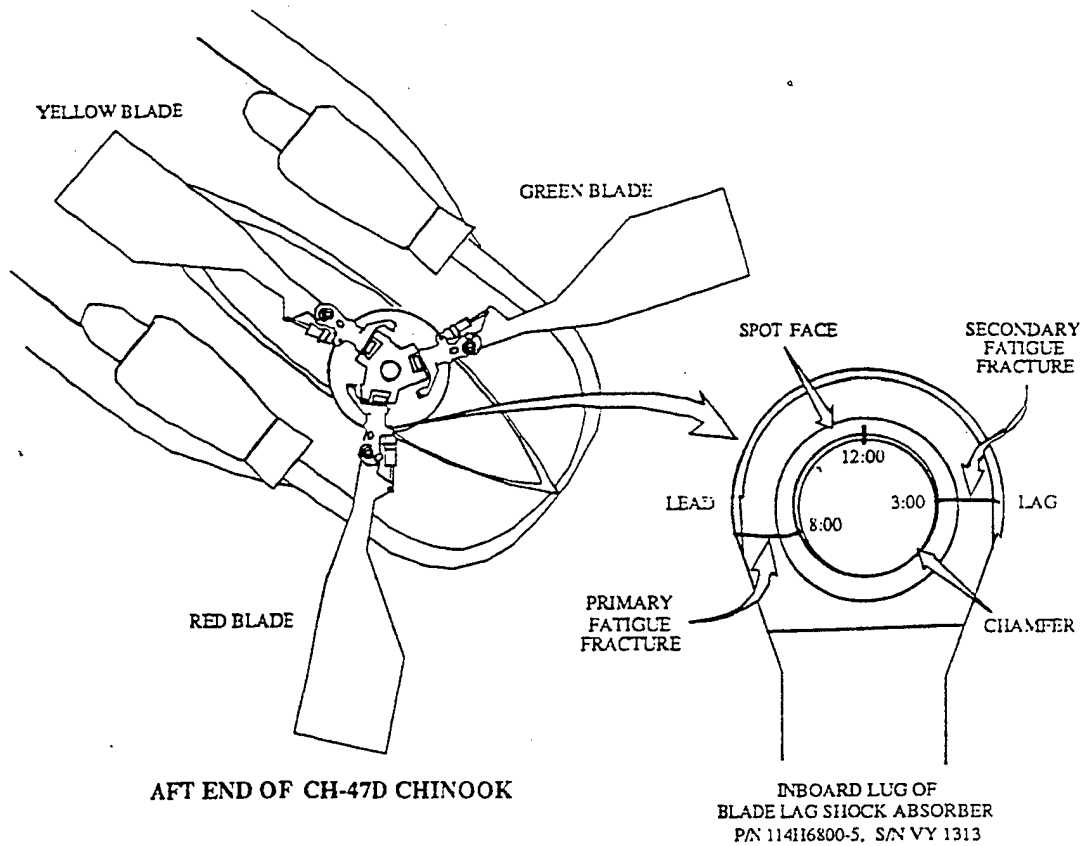
Visual examination of the as-received portions of the inboard lug disclosed two radial through-fractures at the 1.8750 inch diameter spherical bearing bore (Figure 3). The through fractures, labeled A and B, were located at approximately the 3:00 (lag side) and 8:00 (lead side) positions of the bore, respectively. For reference purposes, the 12:00 position is located at the inboard end of the shock absorber, looking down, (Figure 1). Fluorescent penetrant inspection of the segments of the inboard lug revealed no evidence of additional cracks.

Figure 1  
Sketch illustrating the location of the through fractures in the inboard lug of the aft red shock absorber No Scale
