The Boeing Company
P.O. Box 16858
Philadelphia, PA 19142-0858

June 19, 2002
02-8-1130-0916

Subject: Chinook ZD576 Accident on the Mull of Kintyre – Evidence before the House of Lords Select Committee: Request for Boeing Review and Re-simulation.

Enclosure 1
02-8-1130-0916 (ASI Ref. 8-7D20-DSS-0306)

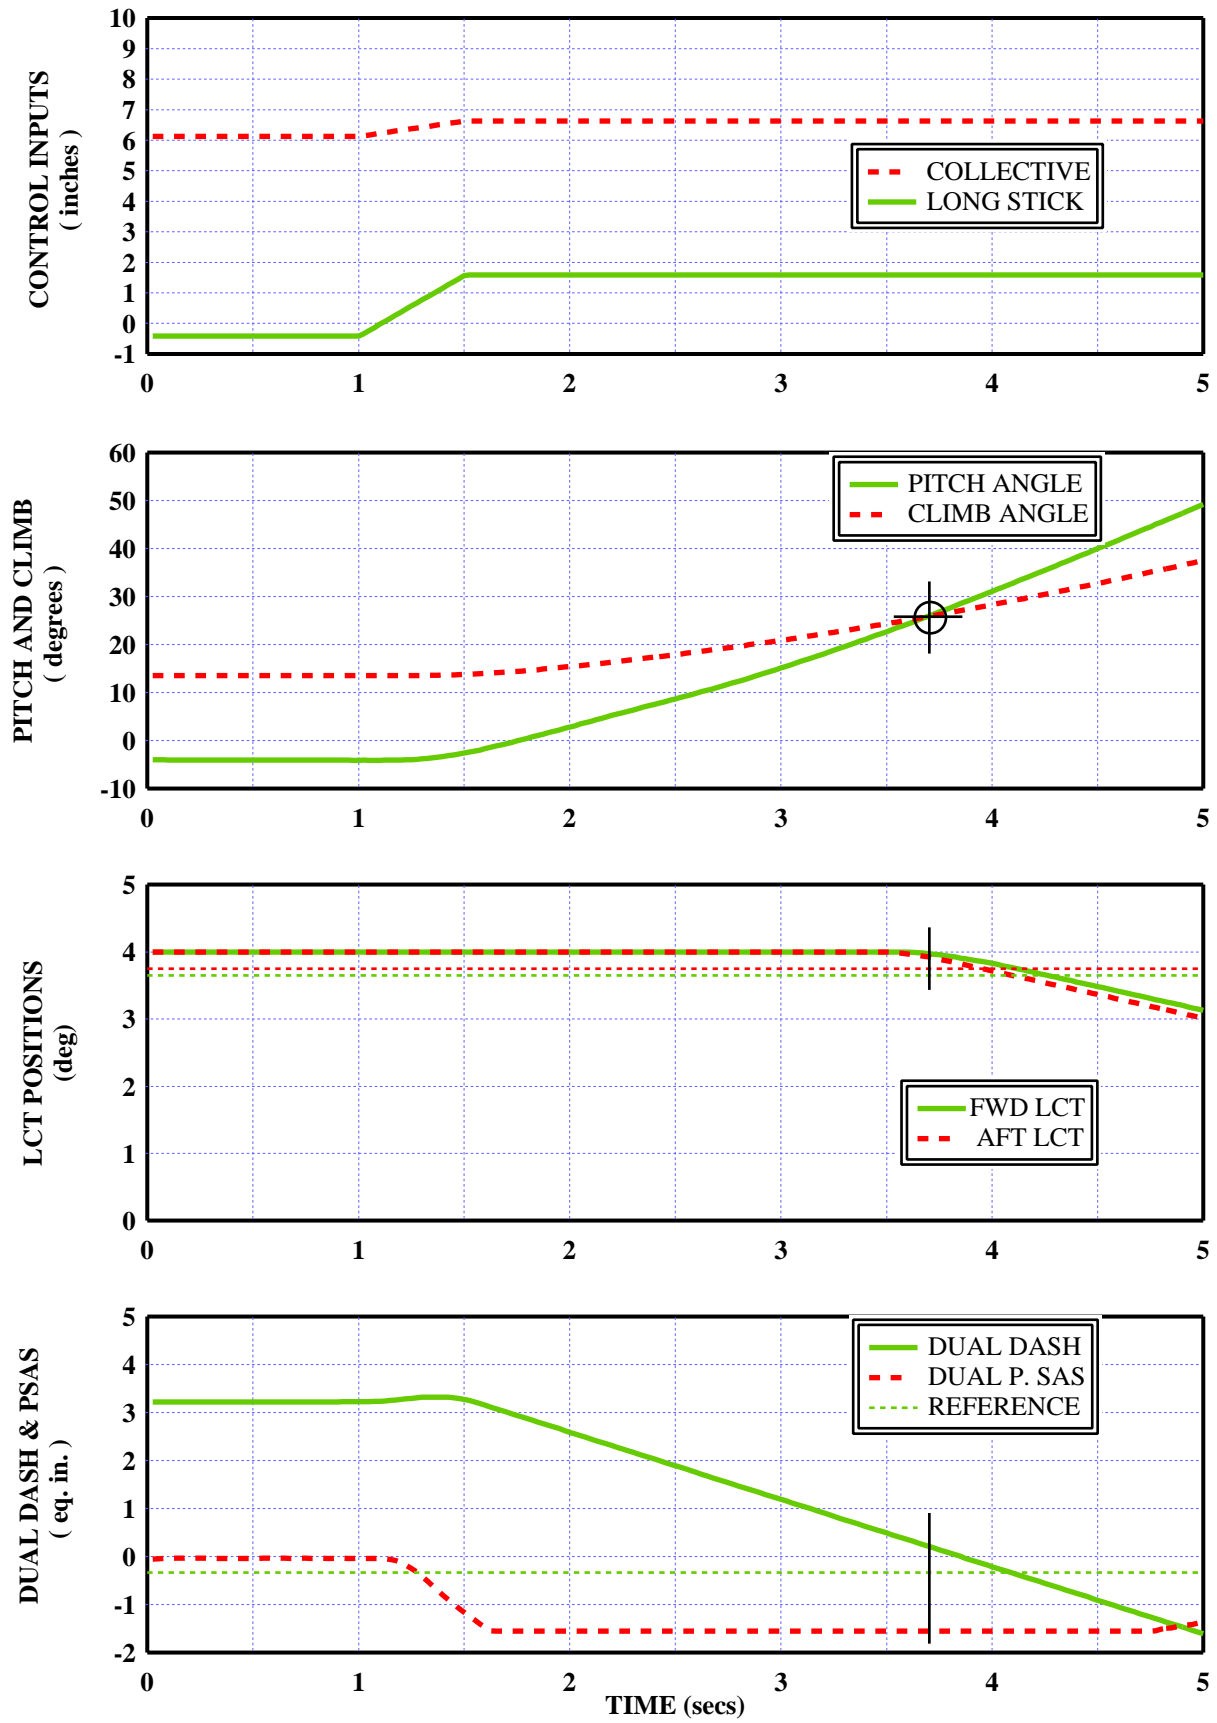
Fig. 1(a) HC MK II SIMULATED CONTROL RESPONSE

Referring again to Figure 1(a), the third and fourth graphs show the LCT and DASH actuator positions. The criteria for the final actuator positions set forth above are obtained from Reference 1, sections 7.4.6 (DASH) and 7.4.7 (LCTs). These final actuator positions are represented by the horizontal dotted lines in each graph. The LCT actuators attain their final extensions at 4.3 sec (fwd) and 3.9 sec (aft), and the DASH actuator attains its final extension at 4.1 sec. These times do not coincide exactly with the impact time indicated in this record by the pitch/climb intersection point at 3.7 sec. However, this is readily explainable by the strong possibility that the electrical system continued to function for a moment or two after impact, thereby allowing the actuators to continue operating until subsequent loss of power. Hence intersection times in Table 5 occurring prior to the attainment of final LCT and DASH positions do not necessarily exclude these cases from further consideration. However, intersection times occurring after these final actuator positions are attained do eliminate such cases, because the decreasing airspeed and increasing pitch attitude during the pitchup maneuver would preclude the actuators from reversing and moving back in the extend direction. In Table 5, the DASH and LCT overrun times are listed for each case. A positive overrun indicates that the actuator has retracted too far beyond the relevant criterion set forth above, and hence the associated pitchup maneuver does not meet this criterion.

Since Case A-24 meets all the Additional Criteria discussed above, and also comes close to meeting the impact angle conditions of 30 deg pitch attitude and 20 deg climb angle, it is selected as a typical example of a possible flight path approach to the point of impact. In Figure 3, the flight path profile at the bottom of Figure 1(b) is superimposed on the terrain profile obtained from Reference 1, section 5.5. Note that the vertical and horizontal scales are not identical, and that the helicopter image is not to scale. The common point of coordination is the impact point at 810 ft AMSL, 3930 ft from the MSL coastline, at 18 sec after the last SuperTANS altitude update. The impact point in Figure 1(a) is considered to be the pitch/climb intersection at 3.7 sec. Backplotting from this intersection to the beginning of the control inputs at 1.0 sec in Figure 1, the conditions at 15.3 sec in Figure 3 are:

Hence the aircraft maneuver and the flight path profile described in Figures 1 and 3, resulting in the impact with terrain at 810 ft AMSL, are within the HC Mk2 flight capabilities, including the final pullup maneuver which meets all the criteria discussed above within reasonable limits.

The pullup maneuver set forth in Figure 1 and the corresponding flight path profile shown on Figure 3, resulting in the impact with terrain at 810 ft AMSL, are within the HC Mk2 flight capabilities for the most likely initial flight conditions at the start of the maneuver.

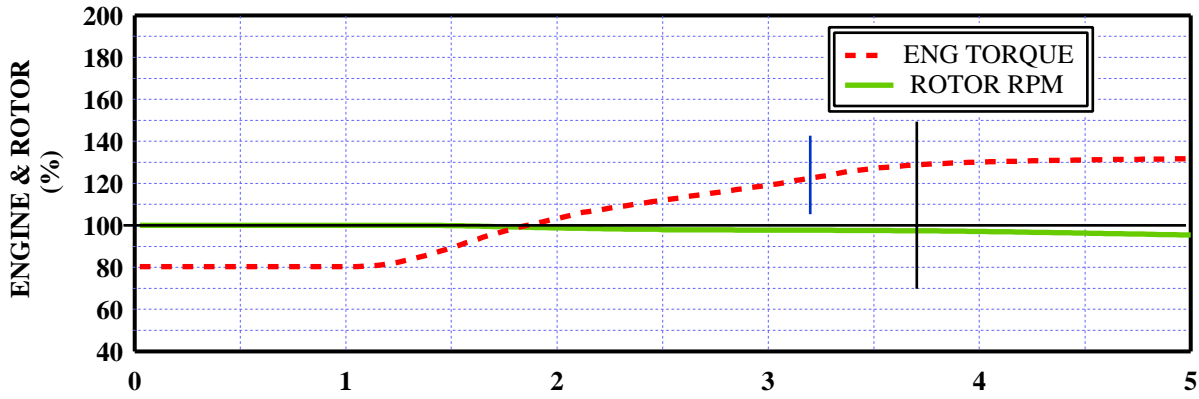
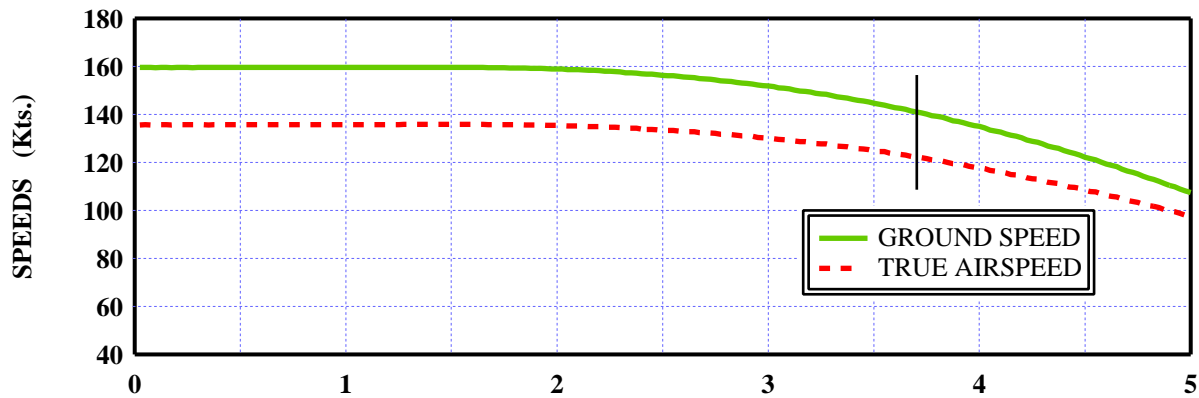
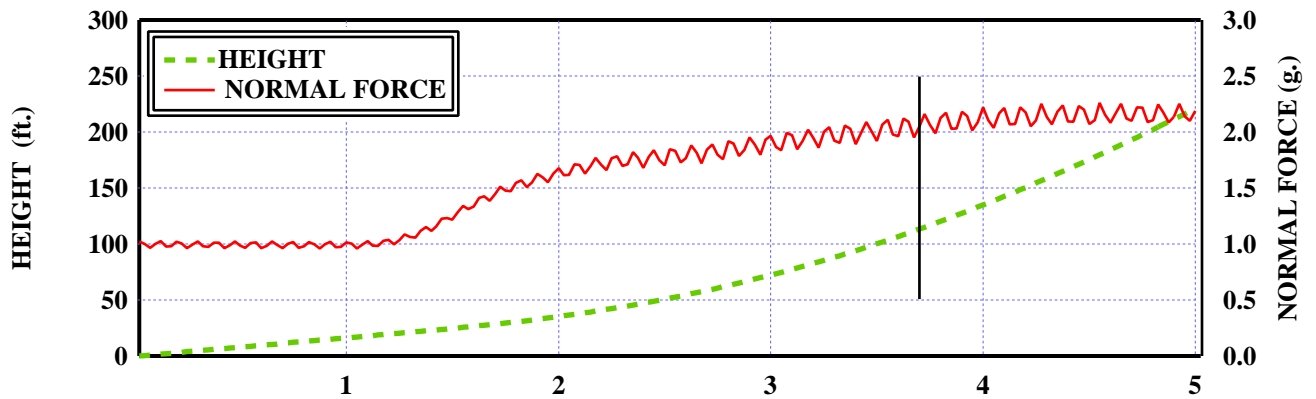
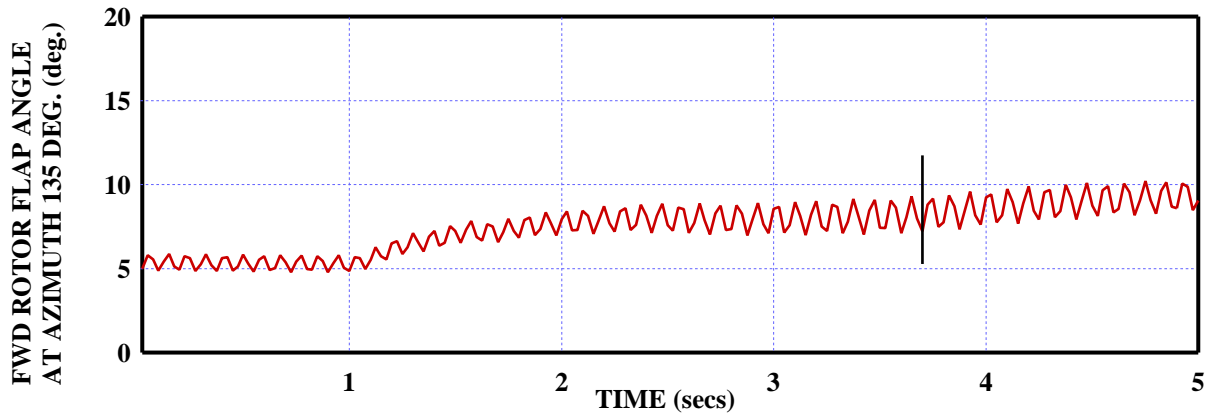
Fig. 1(c) HC MK II SIMULATED CONTROL RESPONSE

From Figure 10 of Reference 1, the forward rotor blade at azimuth 135 deg (i.e. in the right front rotor quadrant) would be the first to strike the hillside. The computed flapping angle of the blade at this azimuth is shown in the bottom graph of Figure 1(c). This trace includes the effects of coning, longitudinal and lateral flapping, and the additional coning due to 2G normal force at 3.7 sec. The oscillatory shape is due to higher blade flapping harmonics at high speed, and entry into the blade stall region during the maneuver. The blade flapping angle at 3.7 sec varies between 7.5 and 9.0 deg in this particular simulation case. In other cases, flapping angles as great as 10 to 12 deg were computed for the blade at this azimuth.

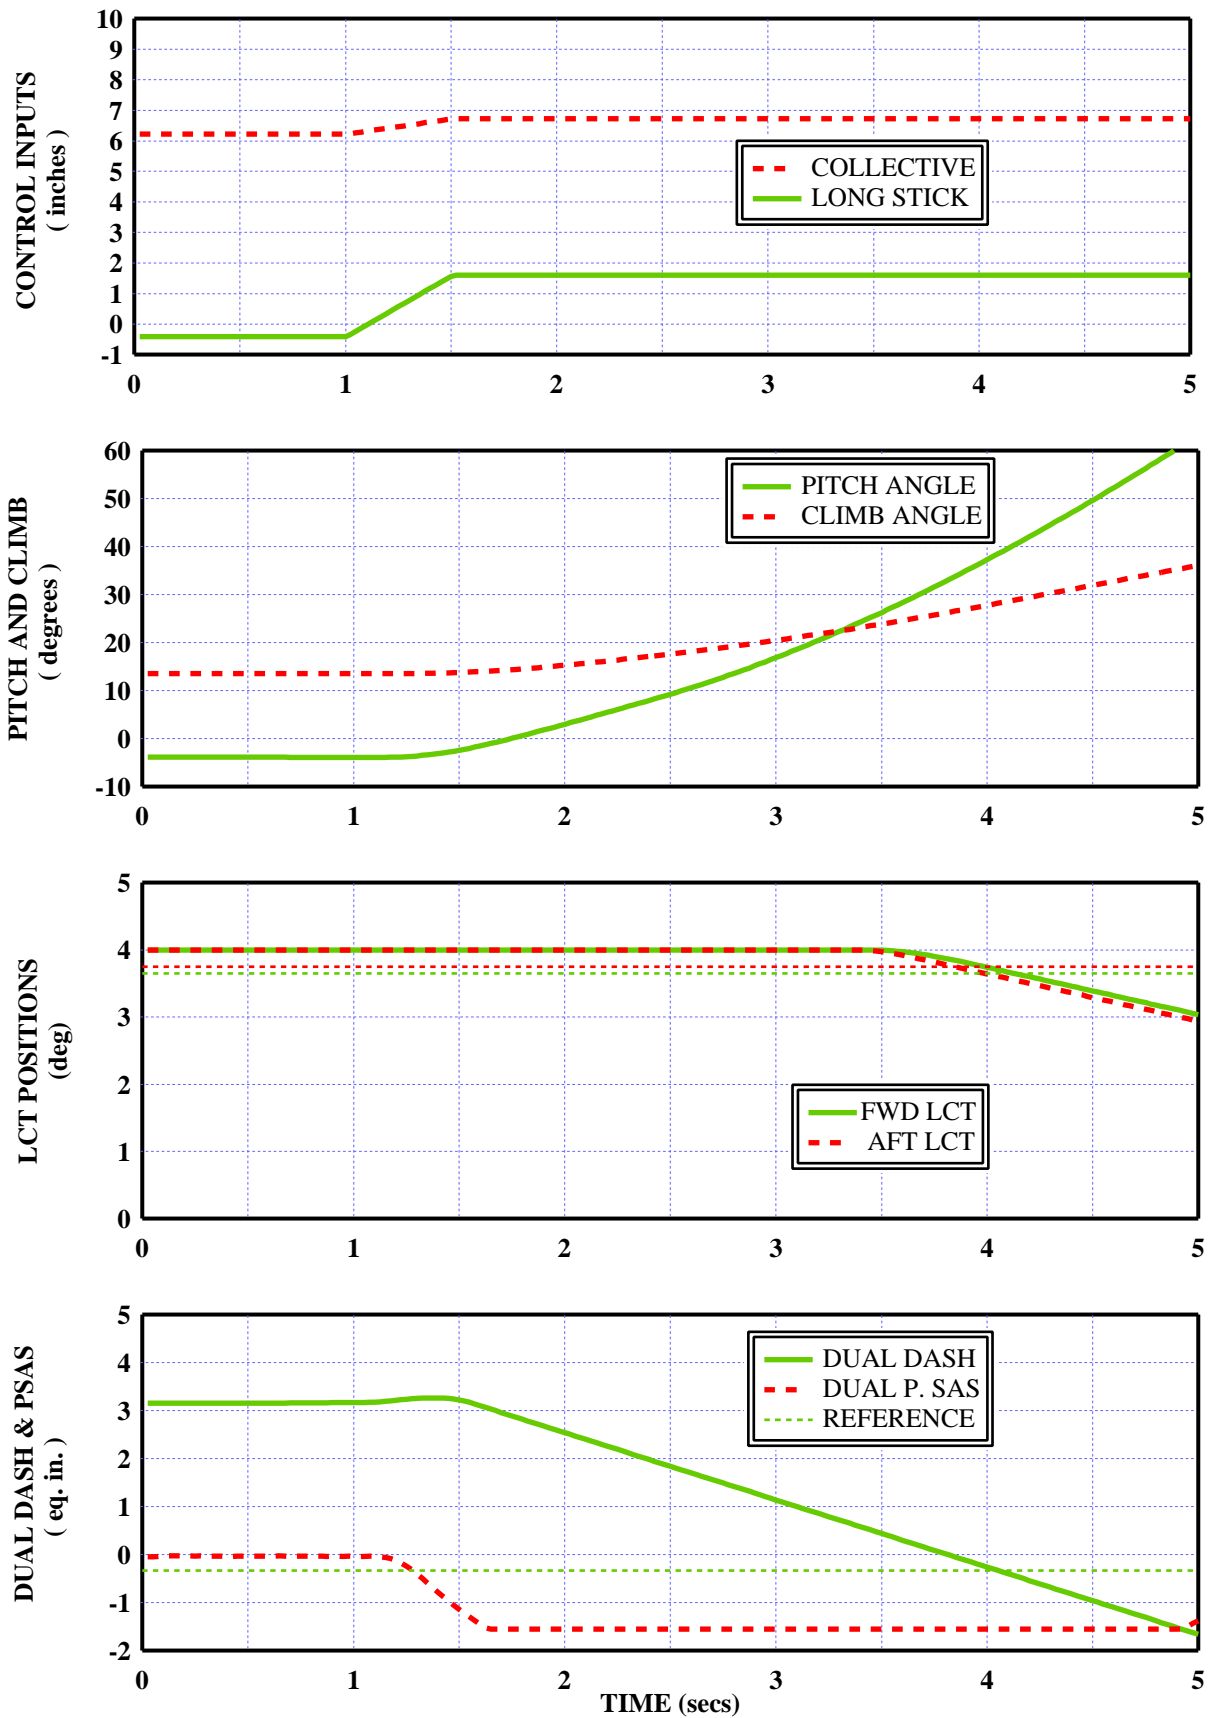
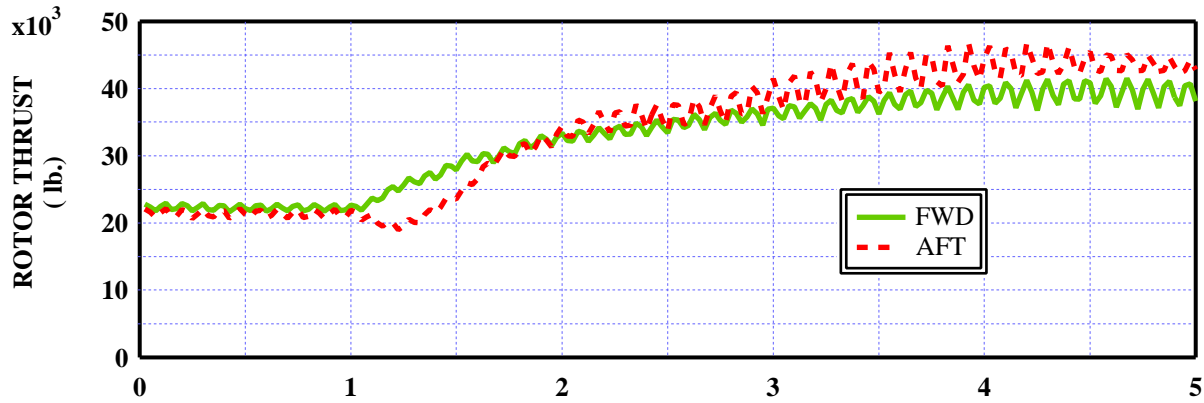
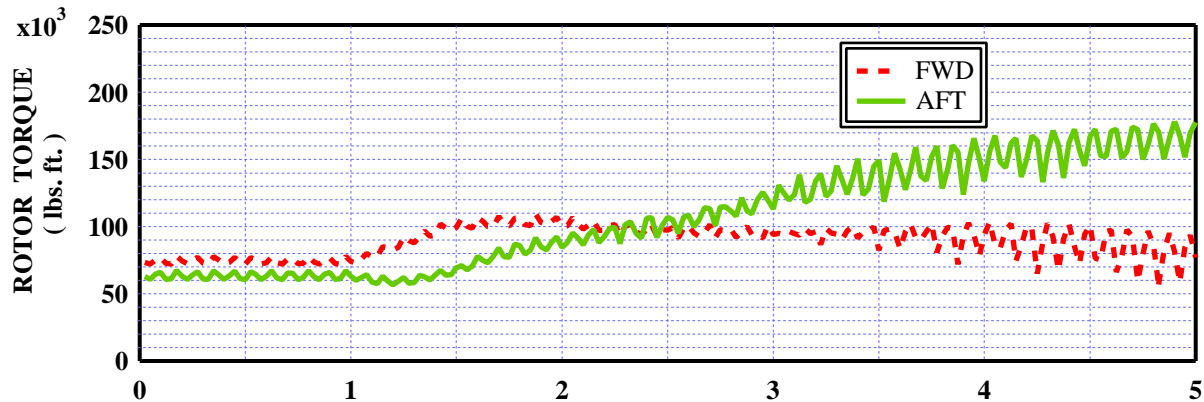
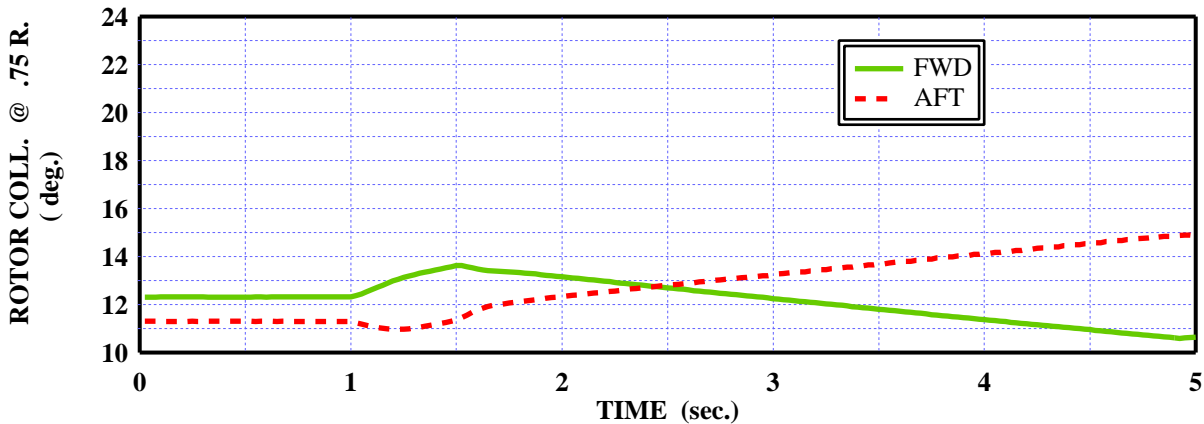
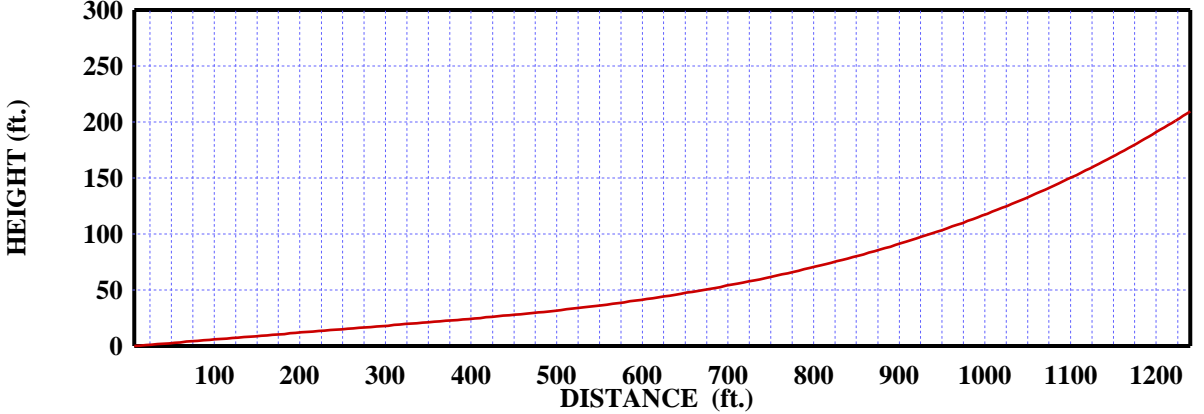
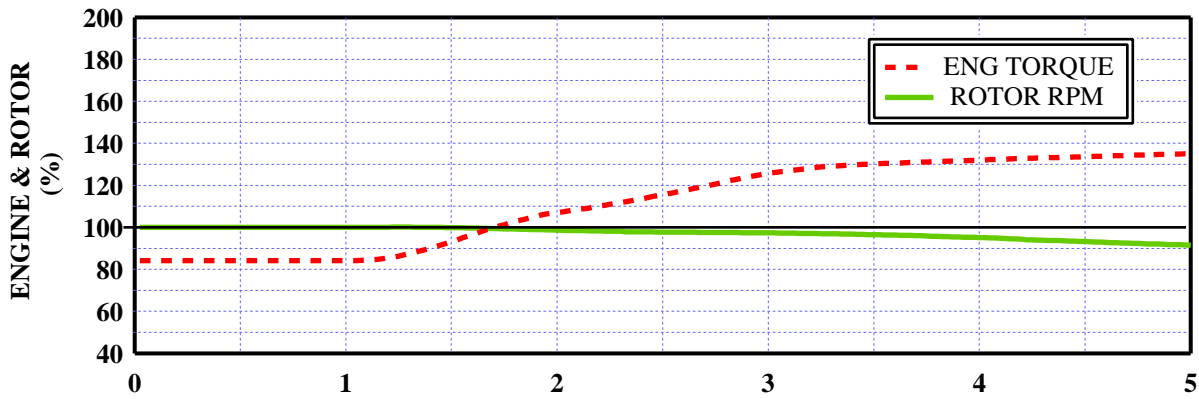
Fig. 4(a) HC MK II SIMULATED CONTROL RESPONSE

Throughout this study, the helicopter gross weight has been taken as 37700 lb, per Section 5.8 of Reference 1. If the weight had been taken as 40000 lb, the typical pullup maneuver in Figure 1(a), (b) & (c) would have been somewhat altered as shown on Figure 4(a), (b) & (c), indicating a quicker pitchup response and a slightly reduced climb angle. A slightly larger collective input and a somewhat smaller aft longitudinal input would likely compensate for these response changes, and the results would then be virtually the same as for the 37700 lb condition.
